St. Caimin's, Inis Cealtra Reconstruction of the Doorway

LIAM DE PAOR and DEIRDRE GLENN*

A programme of excavation and survey was carried out on the early monastic site of Inis Cealtra (Holy Island) in Lough Derg in ten seasons of work, beginning in 1970 and concluding in 1980. A detailed report on this has now been completed for the Department of Arts, Culture and the Gaeltacht, and a summary will be published in this Journal. As part of the Inis Cealtra investigation, a study was undertaken of the design and construction of the doorway of St. Caimin's Church on the island. The doorway was dismantled in the course of this study and was subsequently rebuilt by the Office of Public Works, following the findings reported here.

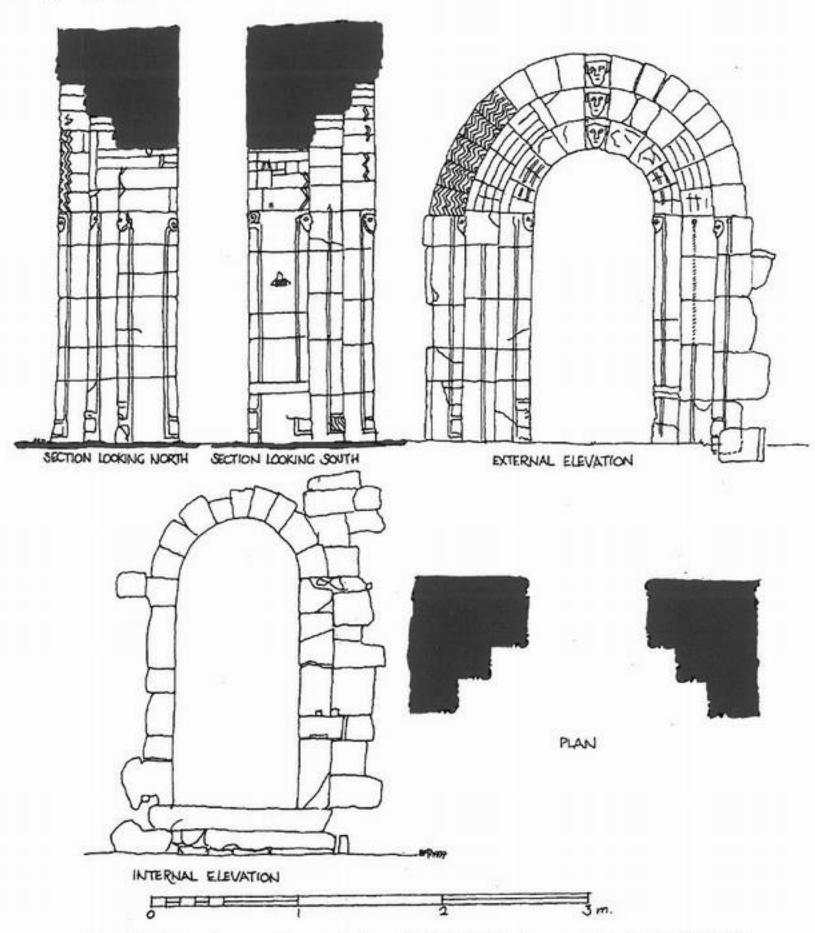
Illus. 7. Elevation, sections and plan of St. Caimin's doorway as rebuilt 1879-80.

Apart from the three Romanesque heads set as keystones (which on examination proved without doubt to be voussoirs of an arch of doorway dimensions) there were several other easily observed anomalies in the 1879–80 reconstruction. First, the jambs uncomfortably lacked the batter, characteristic of proto-Romanesque and Romanesque doorways that have escaped total rebuilding (viz. Clonfert and the inner order of Teampall na Naomh, Inchagoill), and that is suggested in the non-square form of a jamb-stone, found in the modern graveyard of Inis Cealtra, which had not been refitted into the 1880 orders. Next, in the absence of the impost blocks, already noted, the arch rings, in the 1880 reconstruction, sat heavily on the small, recessed, angle head-capitals. In the arch rings, the ornament of the voussoirs, in the outer arris-chevron order and in the second order of concentric band moulding, did not connect or flow consistently, voussoir to voussoir. In fact, in the second order, the flow actually appeared to break angularly, suggesting an original larger circumference for the order. Finally, the springing-stone on the north side of the second order appeared to be reversed from its intended positioning, and a block was employed on the

south side of the second order that in fact was the springing-stone of the south side of the inner (ribbon-chevron) order.

In the summer of 1974 drawings of the doorway were completed (Illus. 7), and tracings were made of them. Each stone of the doorway was then numbered, beginning with the inner order and numbering each order from the north base round to the south base (Illus. 8). Not every voussoir was a single block running through the depth of the archway to the interior; the interior elevation of the doorway was therefore numbered for these, and for the masonry abutment. The four additional heads and the jamb stone were numbered consecutively. These numbers were retained through the reconstruction. Centering was then fitted, the arch was taken down, and the stones removed to a work hut, where they were sorted and arranged according to ornament. The remaining traces of ornament on the weathered Stone 38, which had been positioned in the 1879–1880 reconstruction as a springing-stone of the concentric-roll-moulding order, were measured at this time, and the stone was then properly placed as the south springing-stone of the ribbon-chevron order.

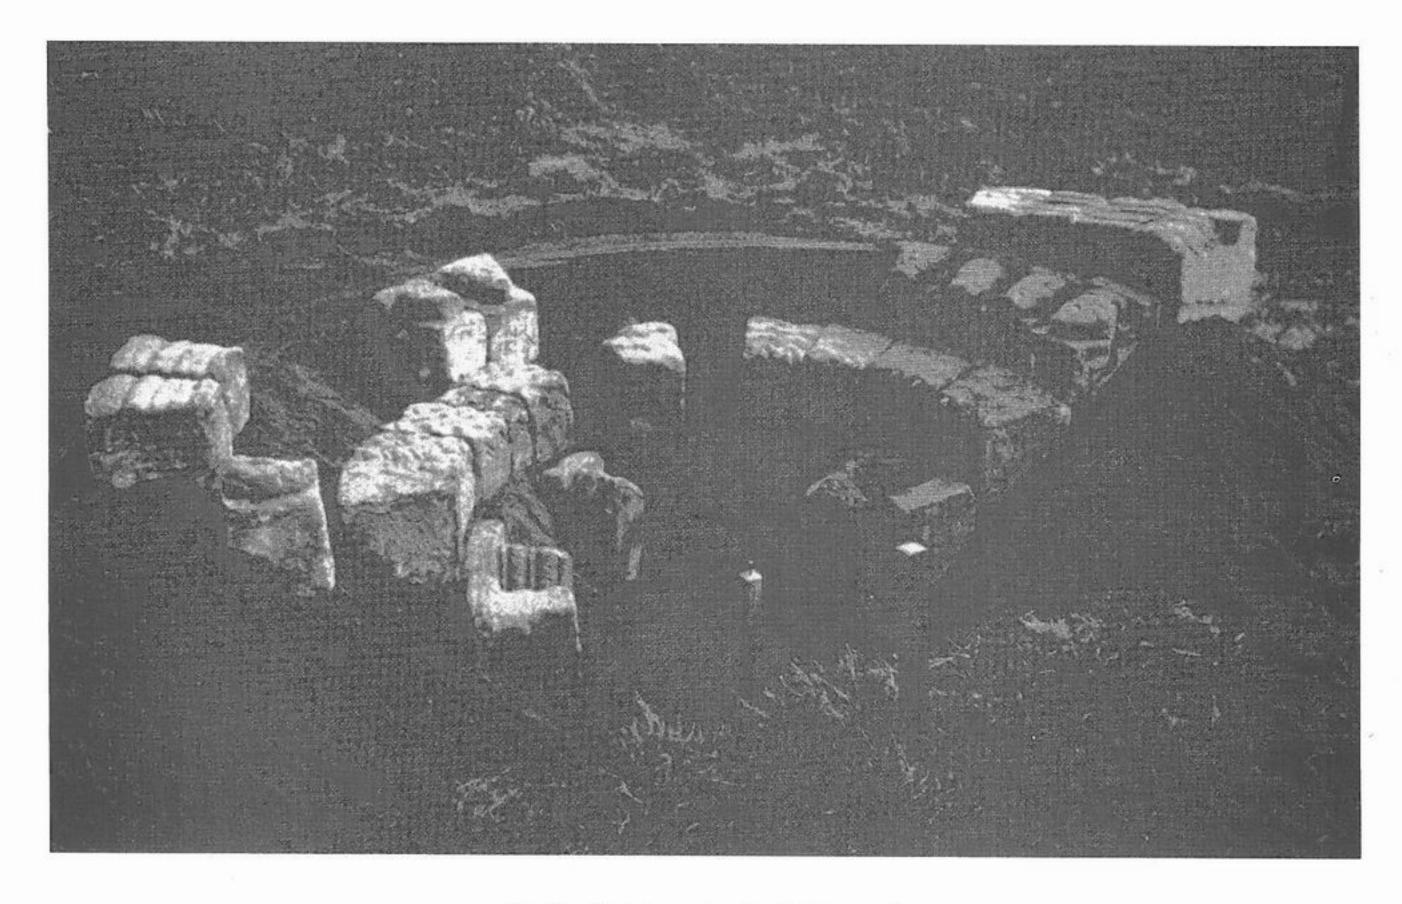
Illus. 10. Sandpit reconstruction of doorway arch.

After all the orders had been placed, it was then possible to tighten the whole of the reconstruction, each order being more secure when the radius was shortened by one or two centimetres. The assembled intrados readings were as follows:

39 cm. Ribbon chevron 58 cm. Arris-chevron 85 cm. Heads 1.06 cm. Hood

These readings further show the extent of the original batter of the door-jambs. Dunraven had measured the jambs at 2 feet, 10 inches apart (approximately 86 cm.). The jambs were originally battered inward to accommodate an arch span of 78 cm. on the inner order. The combined batter

of the jambs therefore amounted to a narrowing of 8 cm. from sill to impost level.

Half way along one side of the pit a stake was sunk, and a nail inserted, to mark the centering point of the arch. A measuring tape and a length of mason's line were attached to the nail. Using the determined radius for each ring, the inner-order chevron was first set in place. Voussoirs 6 and 7, which have a soffit depth equal to he full depth of the doorway (exterior to interior) were wedged into their positions along the intrados circumference marked in the sand. The sand was then piled up in a ring around the marked circumference to lift the remaining voussoirs of the order, until the faces of all the voussoirs were level with stones 6 and 7, even if these voussoirs did not run through the full depth of the archway. So each order was placed, the level of each easily ascertained since the soffits of some of the

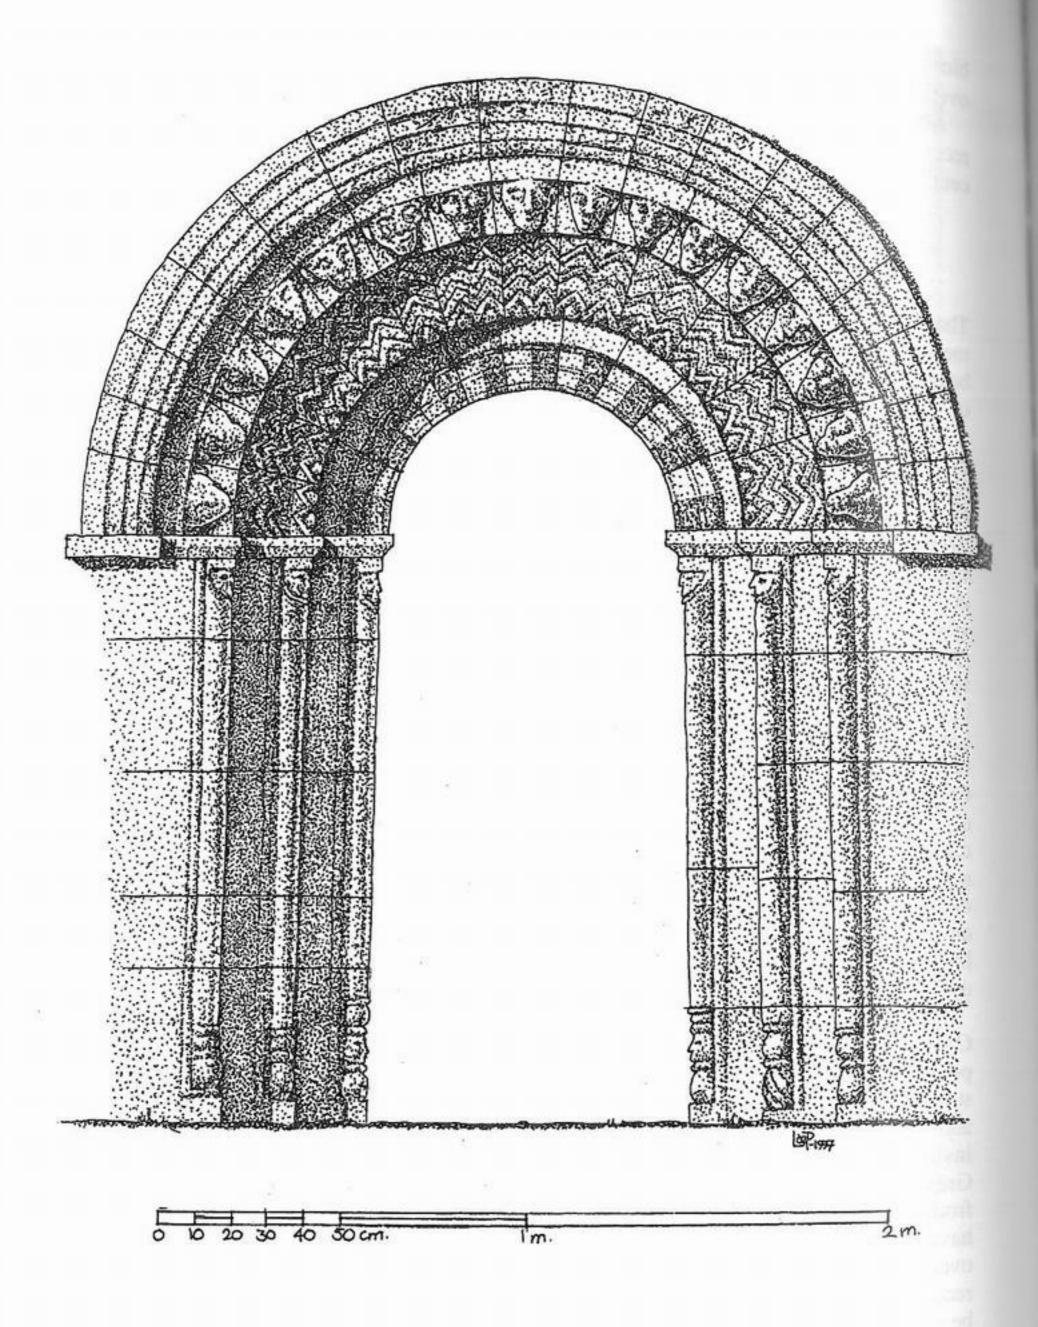
Illus. 11. Elevation to show original design of doorway

Finally, the time had come to assay the arch form as assembled in the sand-pit with the west wall of St. Caimin's and with the size and form of the original, pre-reconstruction, breach as documented by Dunraven. In the work of 1879-80, the base of the doorway had been set on a relatively thick sill foundation, that not only was considerably raised above the twelfth-century ground level, but that sat considerably above the twentieth-century level as well. Lowering this level, tightening the jambs to restore the slight batter they originally had, and adding the documented plain, square-in-section, impost blocks, left a breach with adequate space within which the finished circumference of the four-order arch neatly fits. As previously set, the three-order reconstruction arch had been slightly recessed within the fabric of the tenth-century wall; but with the addition of the fourth order, the hood extends beyond the face of the wall. This has precedent in Irish Romanesque work: one has only to look at Clonkeen, Co. Limerick, which has a recognised relevance in decorative motifs to St. Caimin's,15 but which admittedly has been greatly rebuilt. The chancel arch of the Nuns' Church at Clonmacnoise (which too has been rebuilt, but with an harmonious sense of correctness), however, has an outer hood moulding course extending beyond the face of the chancel wall. But the most obvious example to cite (and one that has not been rebuilt) is the south door of Cormac's Chapel at Cashel, which not only has a protuberant hood course but one that seems in every sense a hood, since the ring sits above and beyond the context of the doorway, having label-stop terminals but lacking ancillary jambs: the restored St. Caimin's hood is similar. The reconstruction drawing, Illus. 11, shows the original form of the doorway as arrived at by the investigation described above.

A label-stop uncovered during the 1971 excavation season in the interior of St. Brigid's Church and bearing no relationship to the Romanesque doorway there, has been placed in position now in the outer order of St. Caimin's. It seems highly unlikely that any further stones belonging to the doorway will be found, since the areas that might well have produced additional voussoirs (the enclosed areas of St. Brigid's Church and St. Michael's, the area inside and immediately in front of St. Caimin's, and the areas adjacent to the Saints' Graveyard) have been extensively excavated. The missing stones may have been removed from the island by pilgrims or by those who collect such for their gardens, or else they may have found a second use a grave-markers in modern burial grounds, now lying buried or overgrown and not to be disturbed. They have been replaced by newly wrought stones in the reconstruction recently completed by the Office of Public Works (Frontispiece), which may

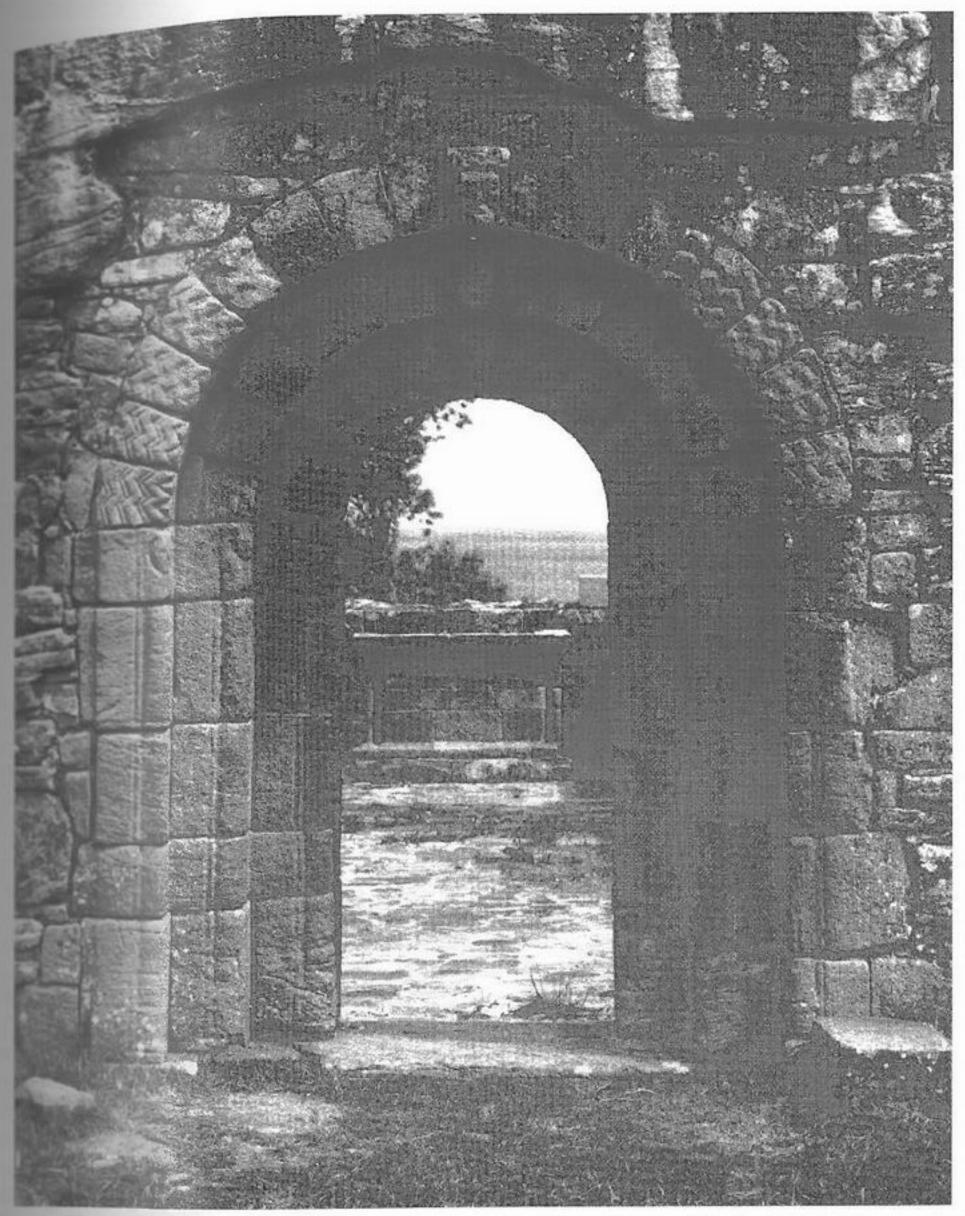
12. St. Caimin's doorway as rebuilt 1879-80. (Photo: Dept. of Arts, Culture and the Gaeltacht, Heritage Services)

The Romanesque doorway of the church of St. Caimin's, Inis Cealtra, was among the first to be re-erected by the old Board of Works. The doorway was totally rebuilt in 1879 and 1880, and its subsequent shape is recorded in published reports. As so assembled, it had several visible irregularities. Most notably, an arch-ring composed of voussoirs with human heads - a distinctive feature of Irish Romanesque - had been eliminated, only three of the surviving heads being used. These were set as key-stones one above the other, placing a Victorian stamp on the final appearance.
