Houses with Decorative Roof Linings at Dunabrattin and Ballynakill, Co. Waterford

A. T. LUCAS

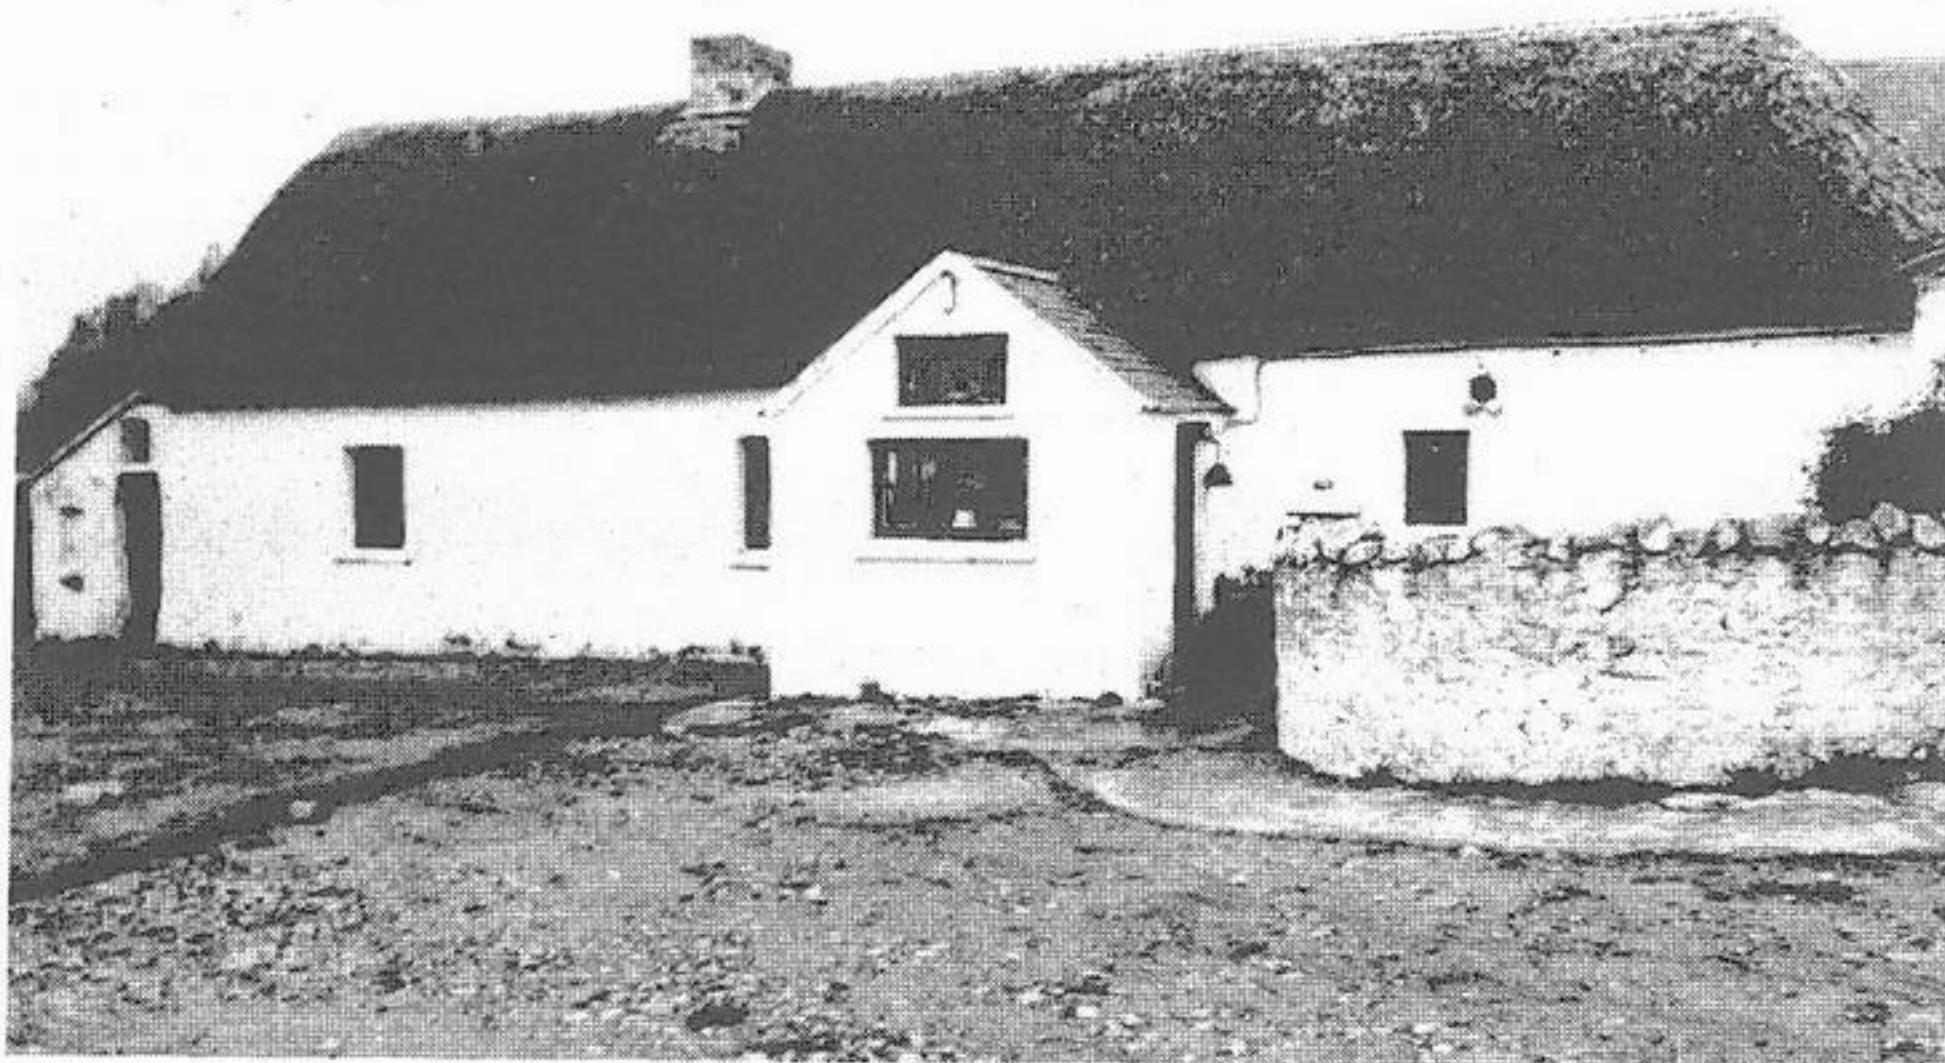
Fig. 1. Dunabrattin. View of front of house.

The original dwelling house is a long, single storey thatched building with a gable at the west end and a hip at the east end (Fig. 1). It has a single chimney at about one third of its length from the west end. A slated porch in front and some rooms at the back are later

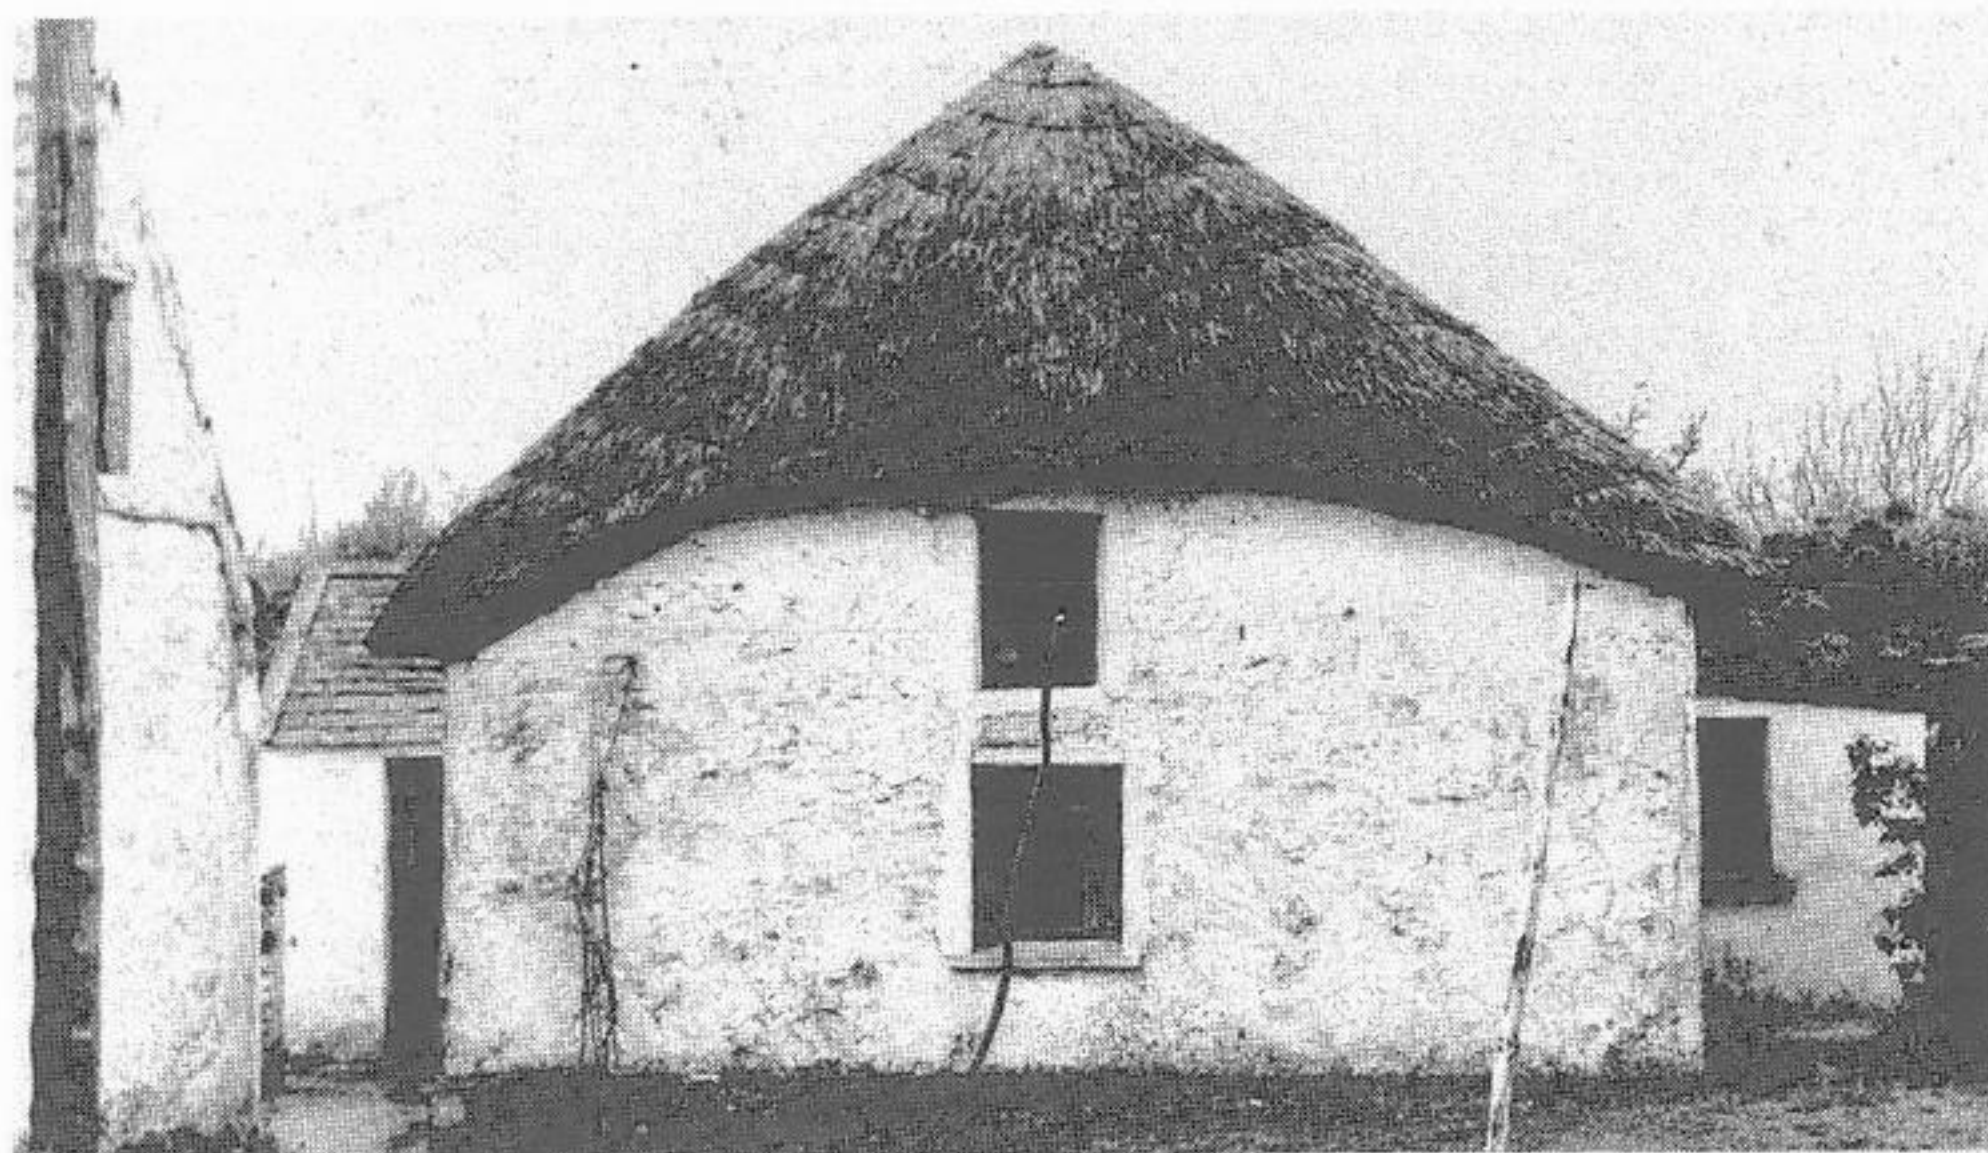
Fig. 3. Dunabrattin. View of hip end with loft window above and later inserted window below.

in the house, was, apparently, inserted in order to light the end compartment at the time when the original single room was subdivided in three (Fig. 3). All three of these small rooms share a common ceiling which forms the floor of a loft in the roof space above them.

Whatever the date and sequence of the alterations in the ground floor lay-out of the east end of the house, there can be no doubt that the loft retains its original features. It is an undivided space extending from the cross-wall to the end wall and is lit by a window 76 cm. high and 56 cm. wide in the centre of the latter. Externally, the thatch on the hip slopes upwards from each side to clear the top of the window (Fig. 3). Were the thatch on

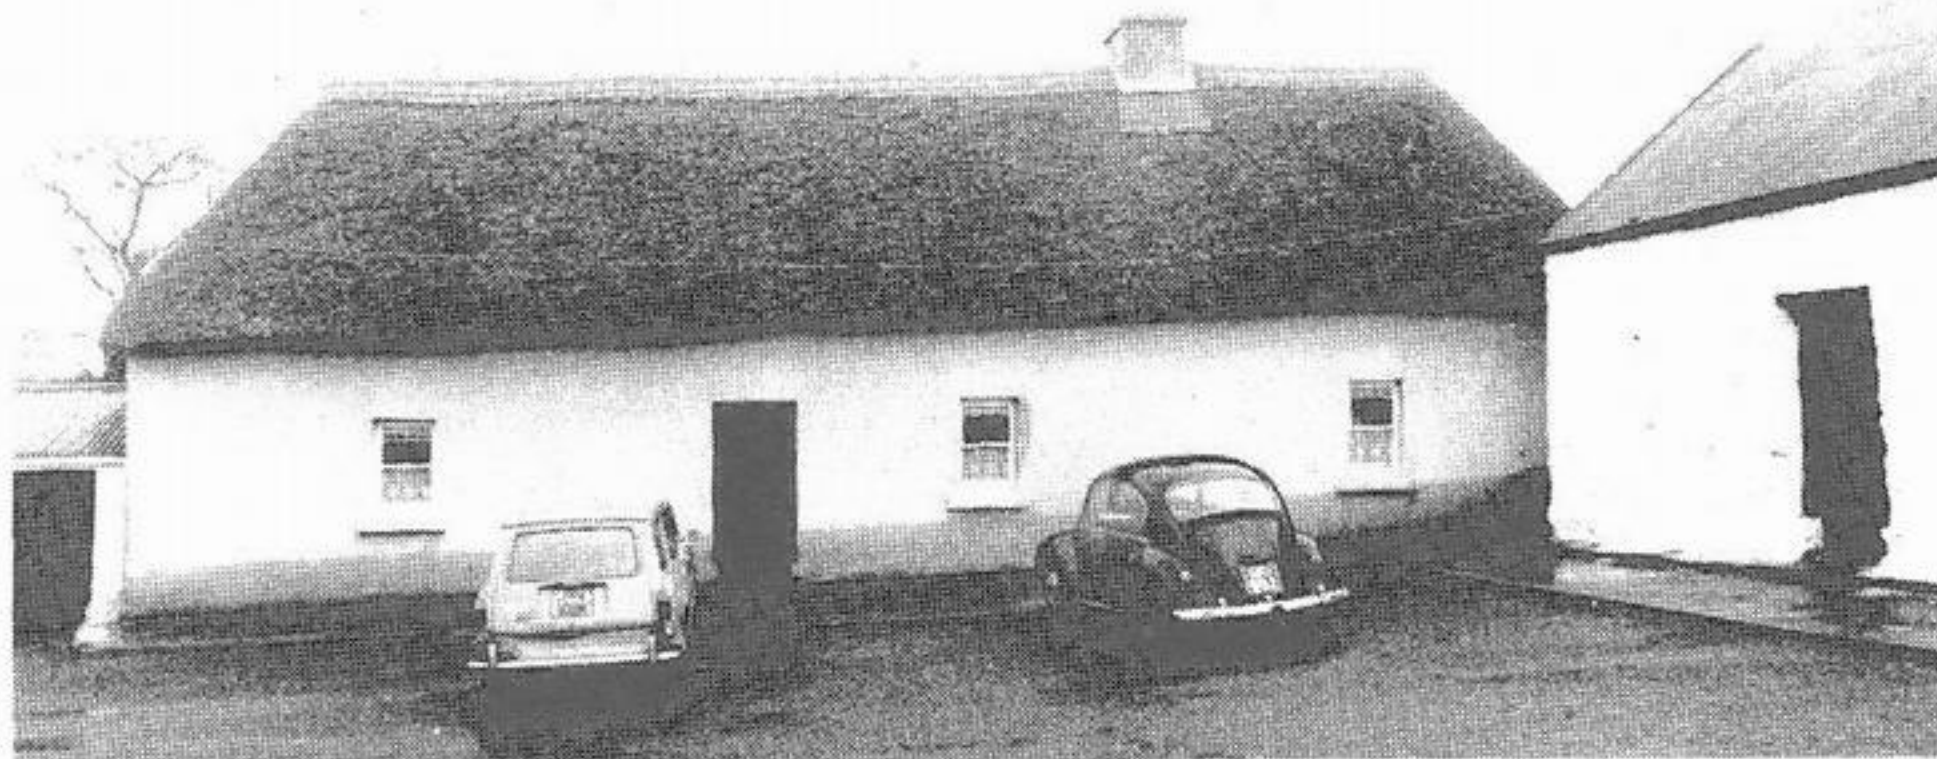
Fig. 8. Ballynakill. View of front of house.

The house was a stone-built single storey building, 15.6 m. long and 4.9 m. wide, externally, with a hipped roof and a chimney much closer to one end than to the other (Fig. 7). Internally, it was divided into three apartments by two cross-walls, one of which contained the kitchen fireplace (Fig. 8). It had been scrupulously maintained and was in an excellent state of preservation, inside and out. The thatched roof had a fresh decorative trim on the ridge and a three-band panel on the roof slope immediately below the chimney.

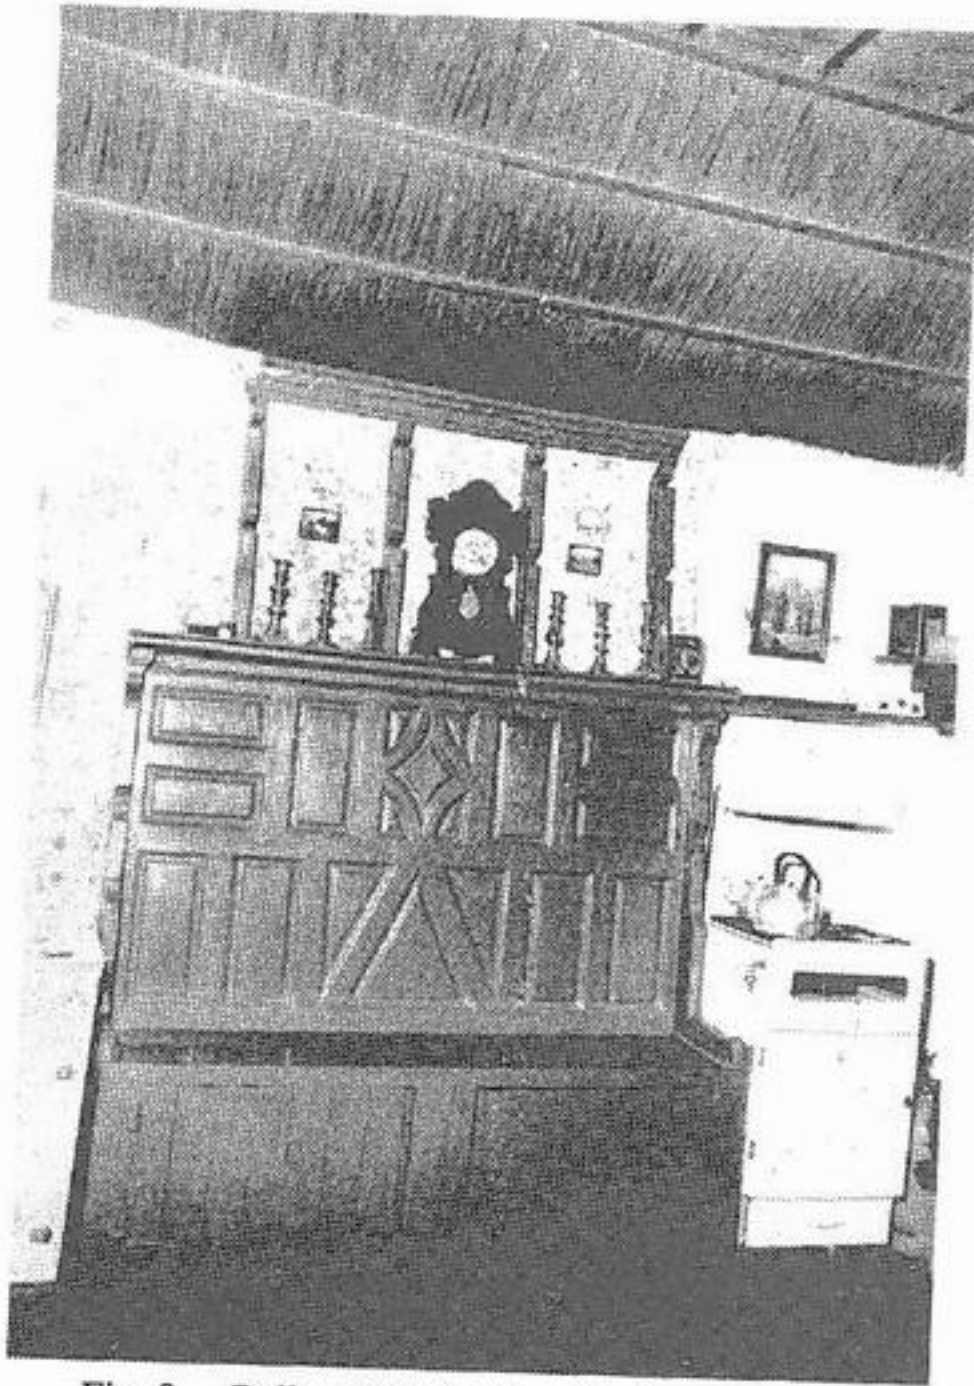
Fig. 9. Ballynakill. Settle with cleevy above.

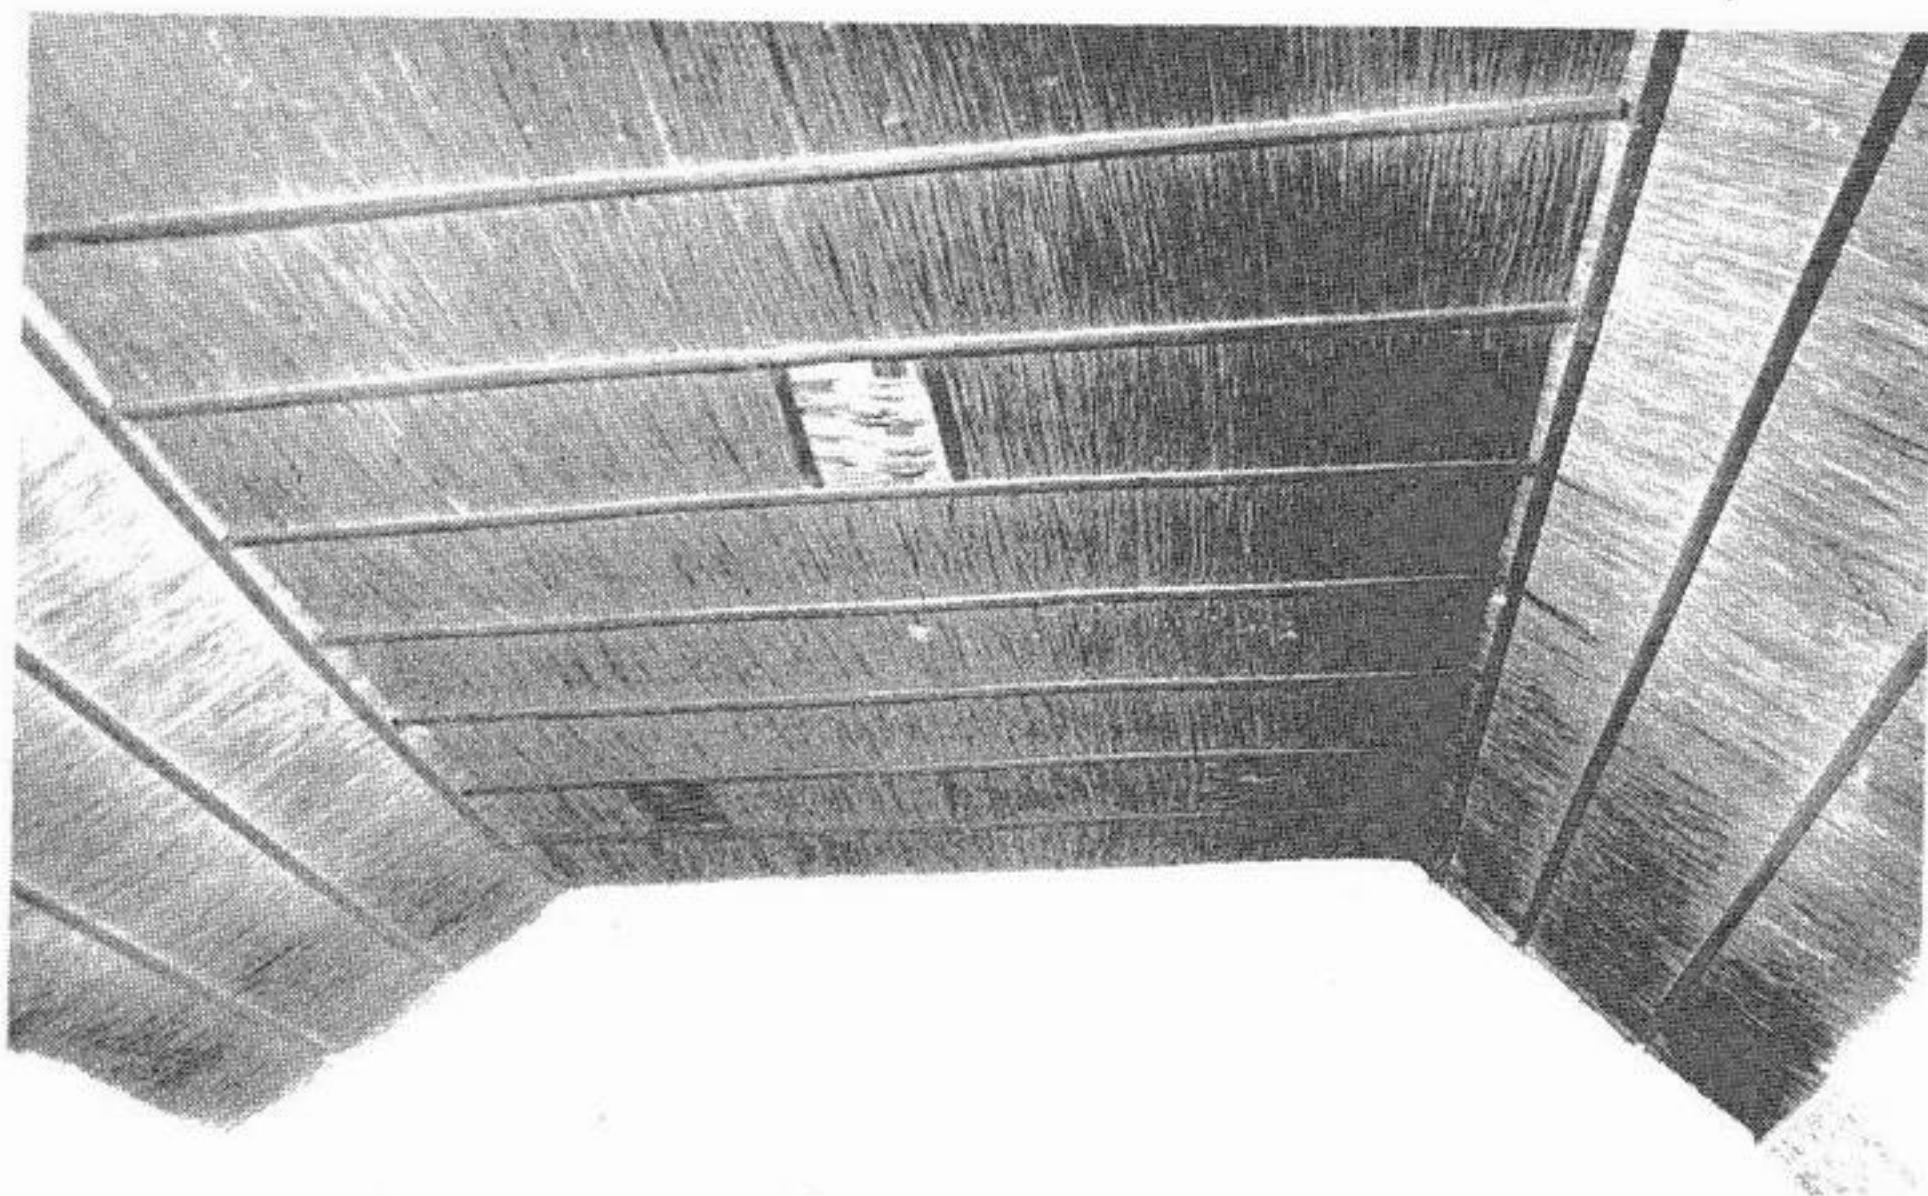
Fig. 12. Ballynakill. Decorative roof lining in kitchen.

The kitchen roof was a truncated triangle in cross-section and the straw lining completely concealed the rafters and their cross-ties. It is, therefore, impossible to say if, on the horizontal upper part of the roof, the lining was applied to the original cross-ties or to a second of ties inserted at a lower level. If the lining is coeval with the building of the house, the cross-ties may have been made longer and set lower than usual with a view to the fixing of the lining to them. The lining was applied in zones which ran longitudinally along the two sloping sides of the roof and transversely across the horizontal upper part (Figs. 12 and 13). There were three zones on each of the sloping sides, the lower two being 37 cm. wide, the uppermost slightly narrower. On the horizontal upper part there were eleven full zones and a narrower one next to the cross-wall opposite the fireplace, all running at right angles to the long axis of the roof. The straws in each zone were at right angles to its long axis so that those on the sides of the roof ran up and down the slope while those in the horizontal upper part ran parallel to the long axis of the roof. The straws of the lining lay side by side with great regularity and appeared to form a layer of considerable thickness. The lining straws were held in place by laths about 50 mm. wide and 10 mm. thick with a slight keel along the median line. At intervals about 42 cm., they were fastened in place by iron nails which were, presumably, driven into the rafters on the sloping sides and into the cross-ties on the upper horizontal area. As the lower ends of the straws in each of the upper zones on the slopes of the roof passed under the lath below them and emerged to overlie the upper ends of the straws in the zone below them, it is evident that the work of applying the lining to the roof slopes was carried out zone by zone from the bottom upwards. A distinguishing feature of this roof lining was the presence of five ornamental panels of 'woven' pattern, symmetrically arranged on the horizontal part of the roof (Fig. 13). In the second zone from the cross-wall at each end of the kitchen there were two panels, each near one end of the zone and both at the same
