Excavations at the Base of St. Patrick's Cross, Cashel

ANN LYNCH

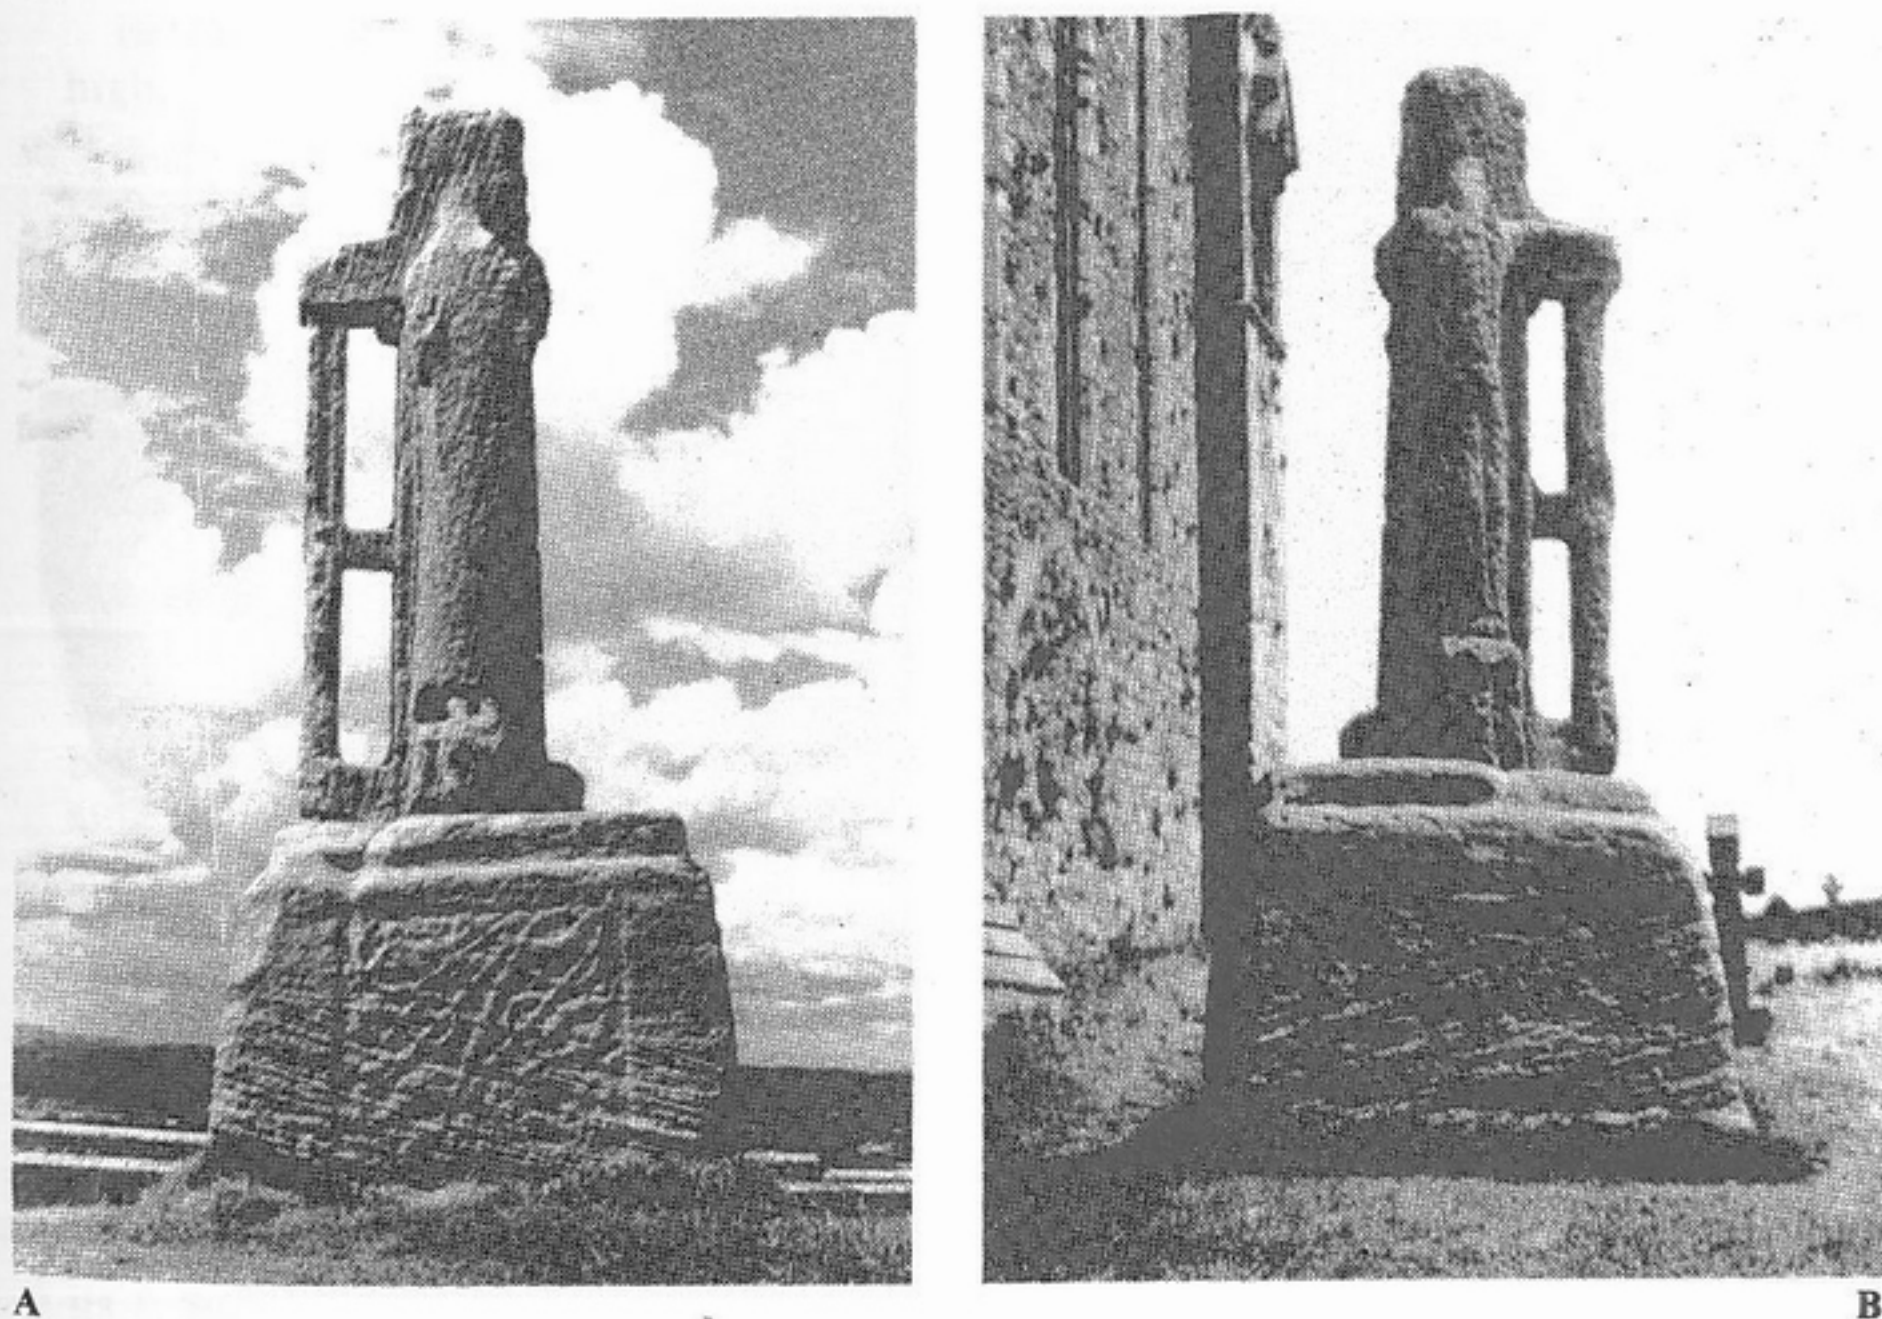
Fig. 1. St. Patrick's Cross, taken before excavation; A. east face, B. west face.
(Photo: Office of Public Works.)

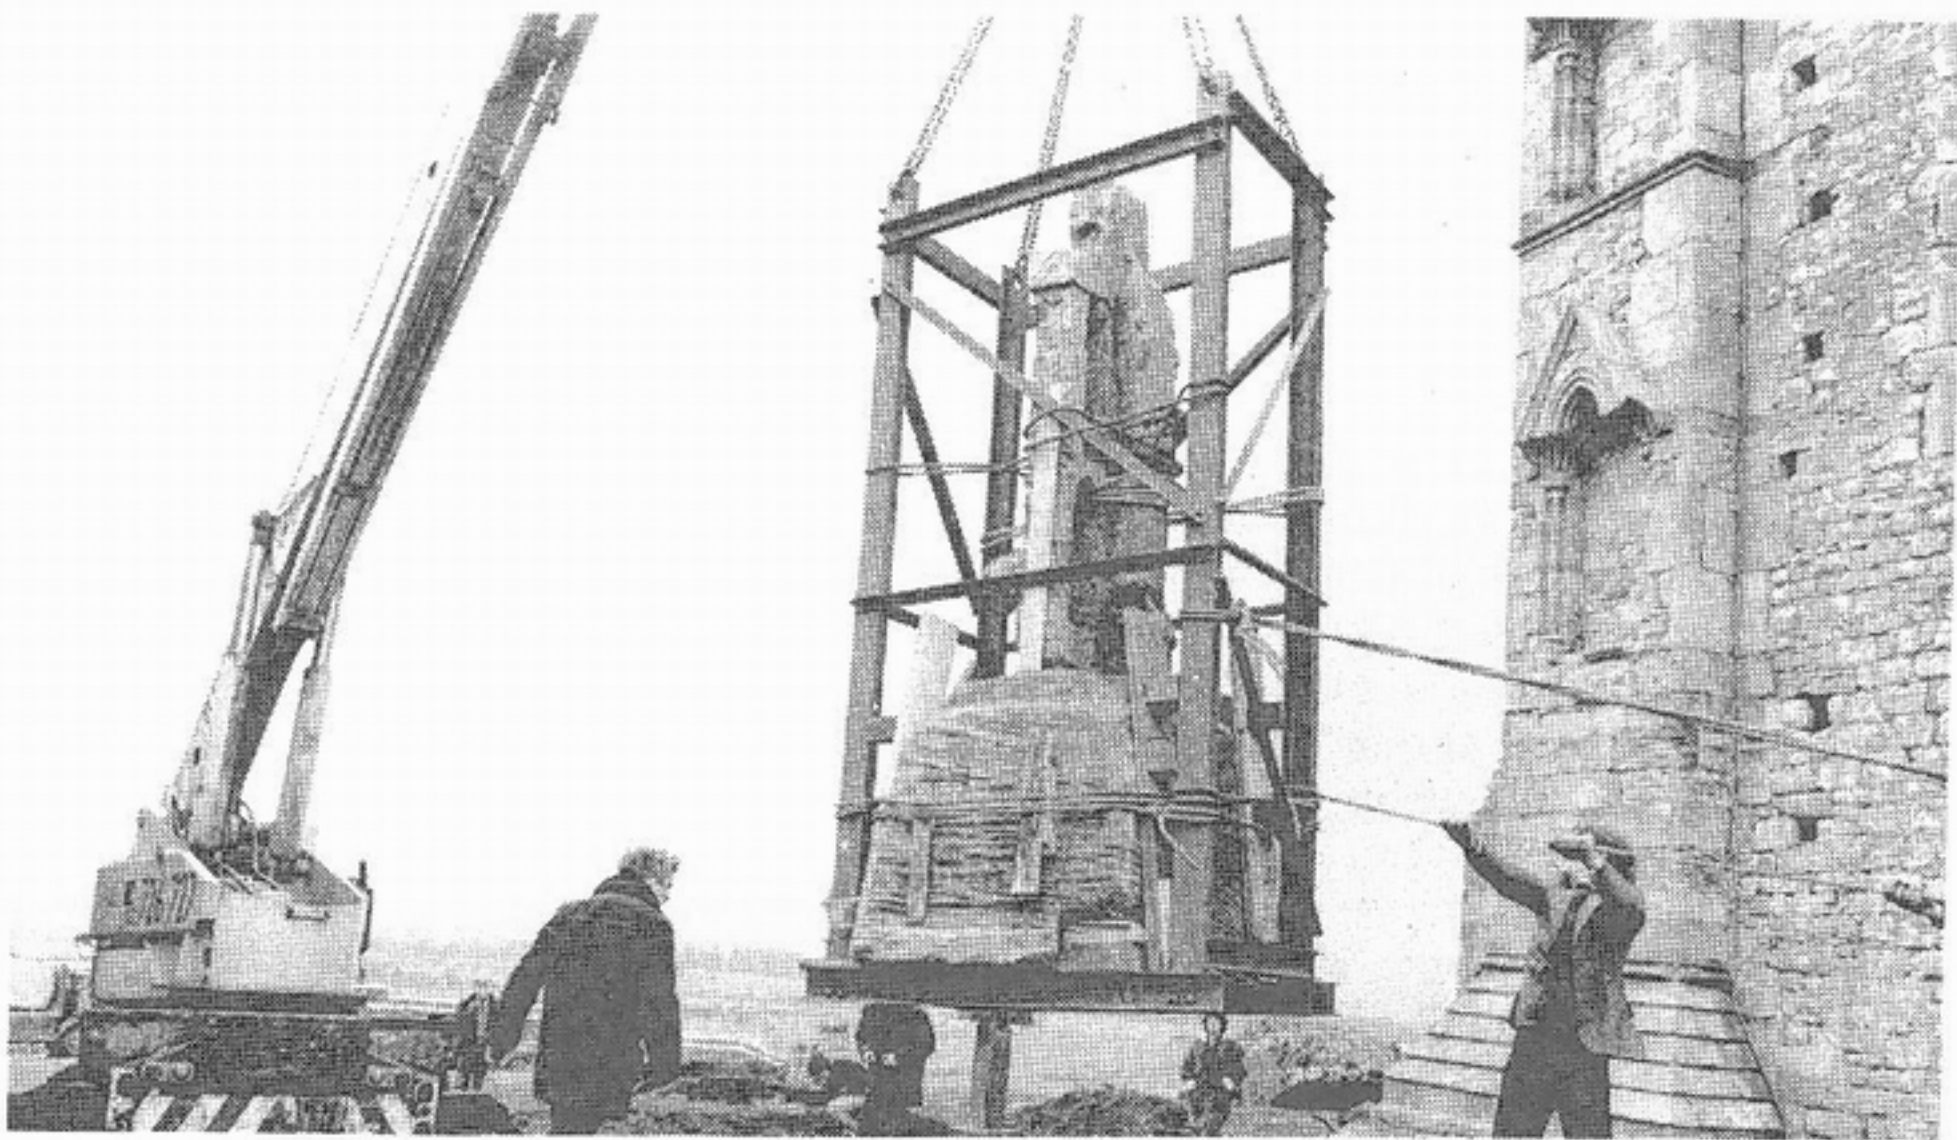
Fig. 2 St. Patrick's Cross, Cashel, being lifted for transference to the Vicars' Choral Building.
(Photo: Office of Public Works.)

When the cross was lifted (Fig. 2) it was noticed that a rectangular-shaped depression (79cm. long, 67cm. wide, 23cm. deep) had been cut into the underside of the base (Fig. 3). Loose brown soil had accumulated in this depression, probably brought in by burrowing animals who could have squeezed through one of the several gaps which existed between the underside of the base and the underlying mortar layer. Such burrowing animals must also account for the fragments of newspaper, a camera flash-cube and recent animal bone, all found in the brown soil.

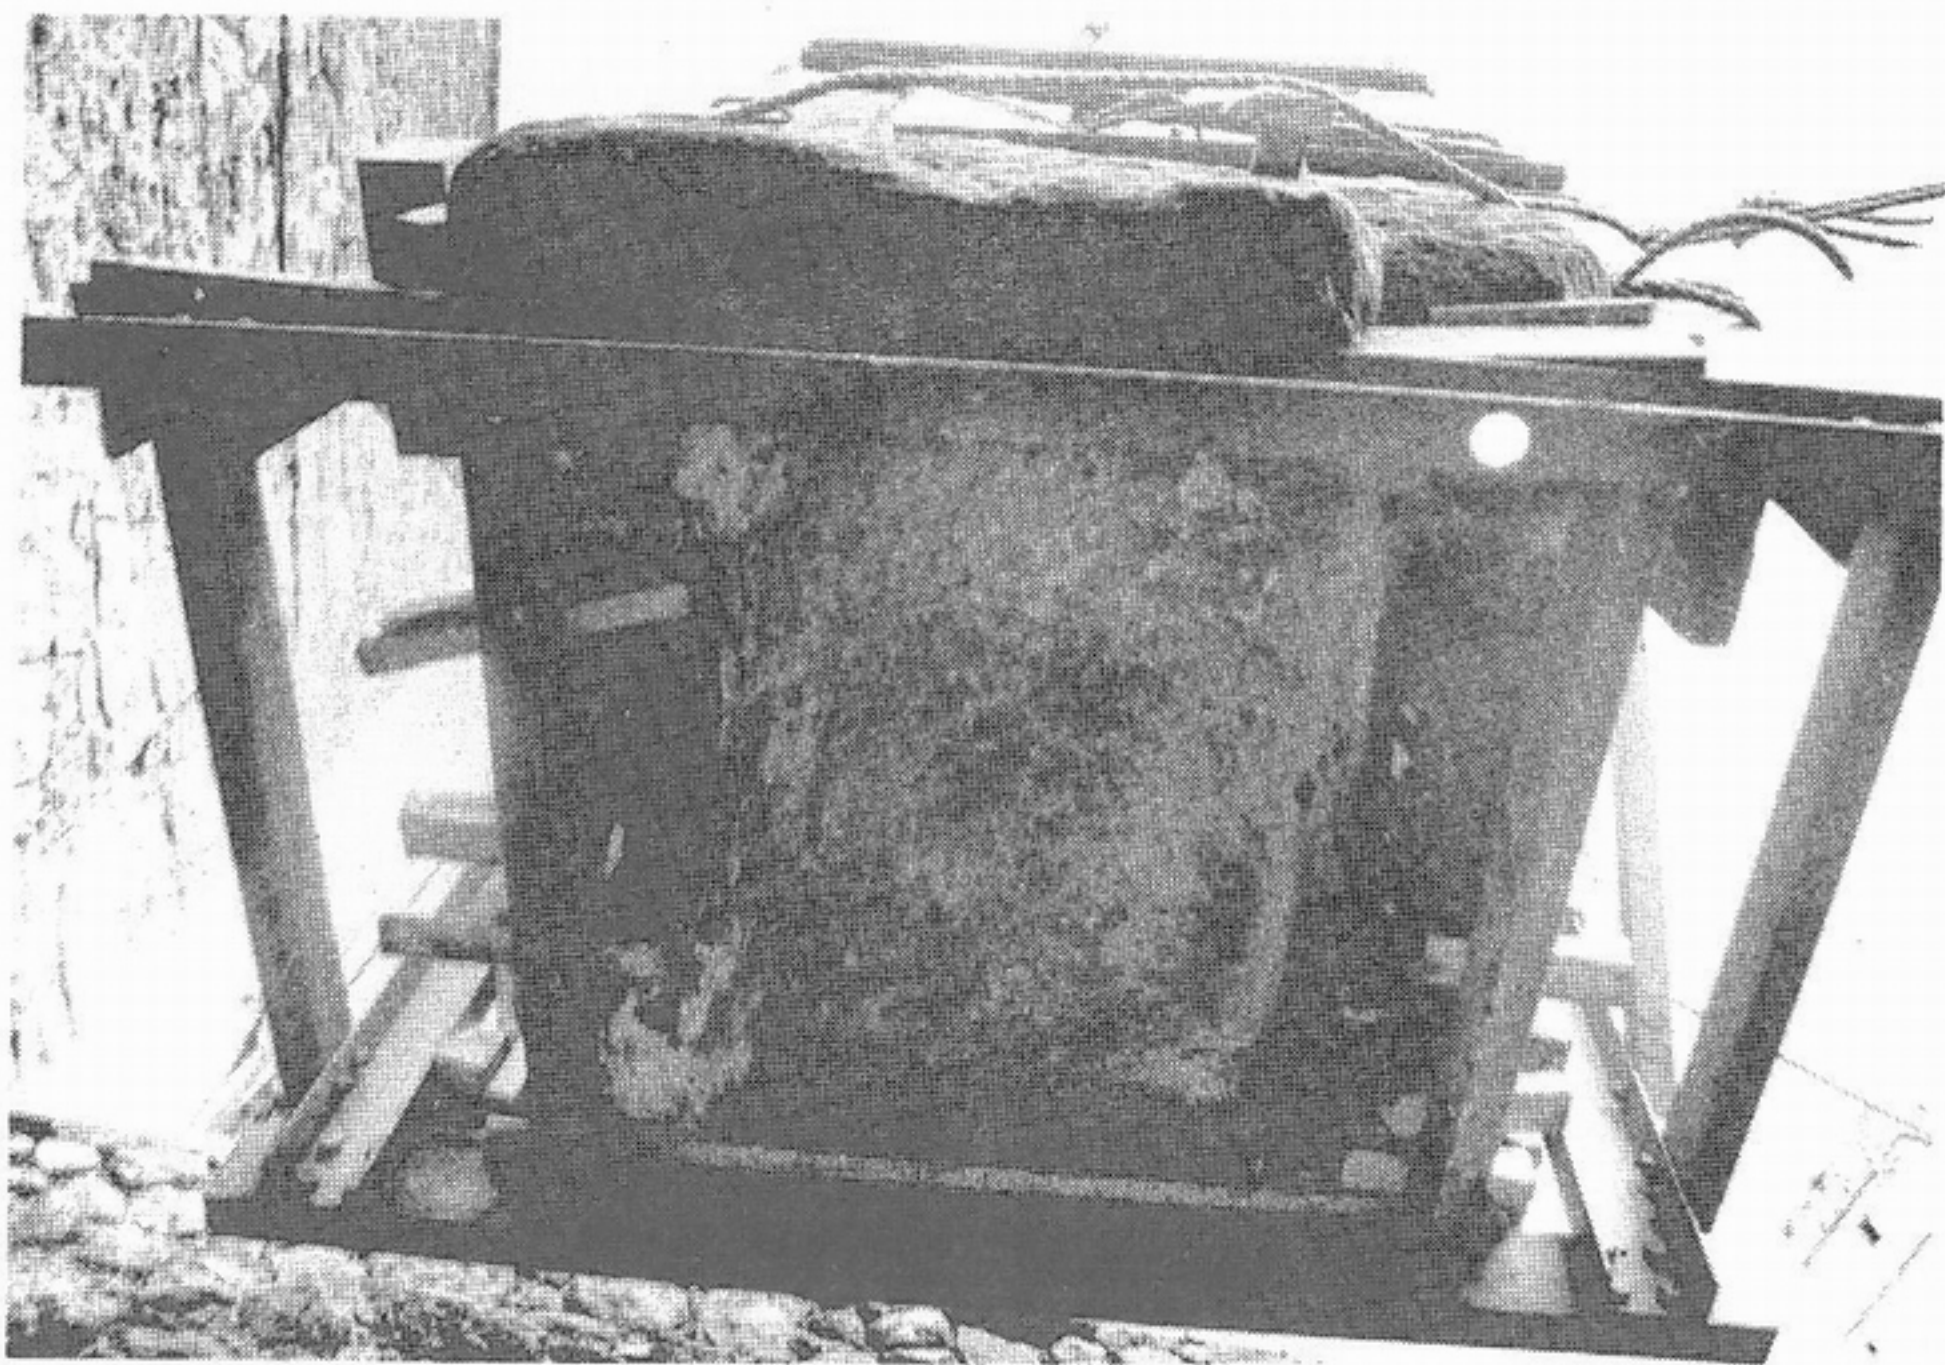
Fig. 3. View of the underside of the cross, showing the rectangular-shaped depression, taken as the cross was being lowered into the Vicars' Choral Building. (Photo: Office of Public Works.)

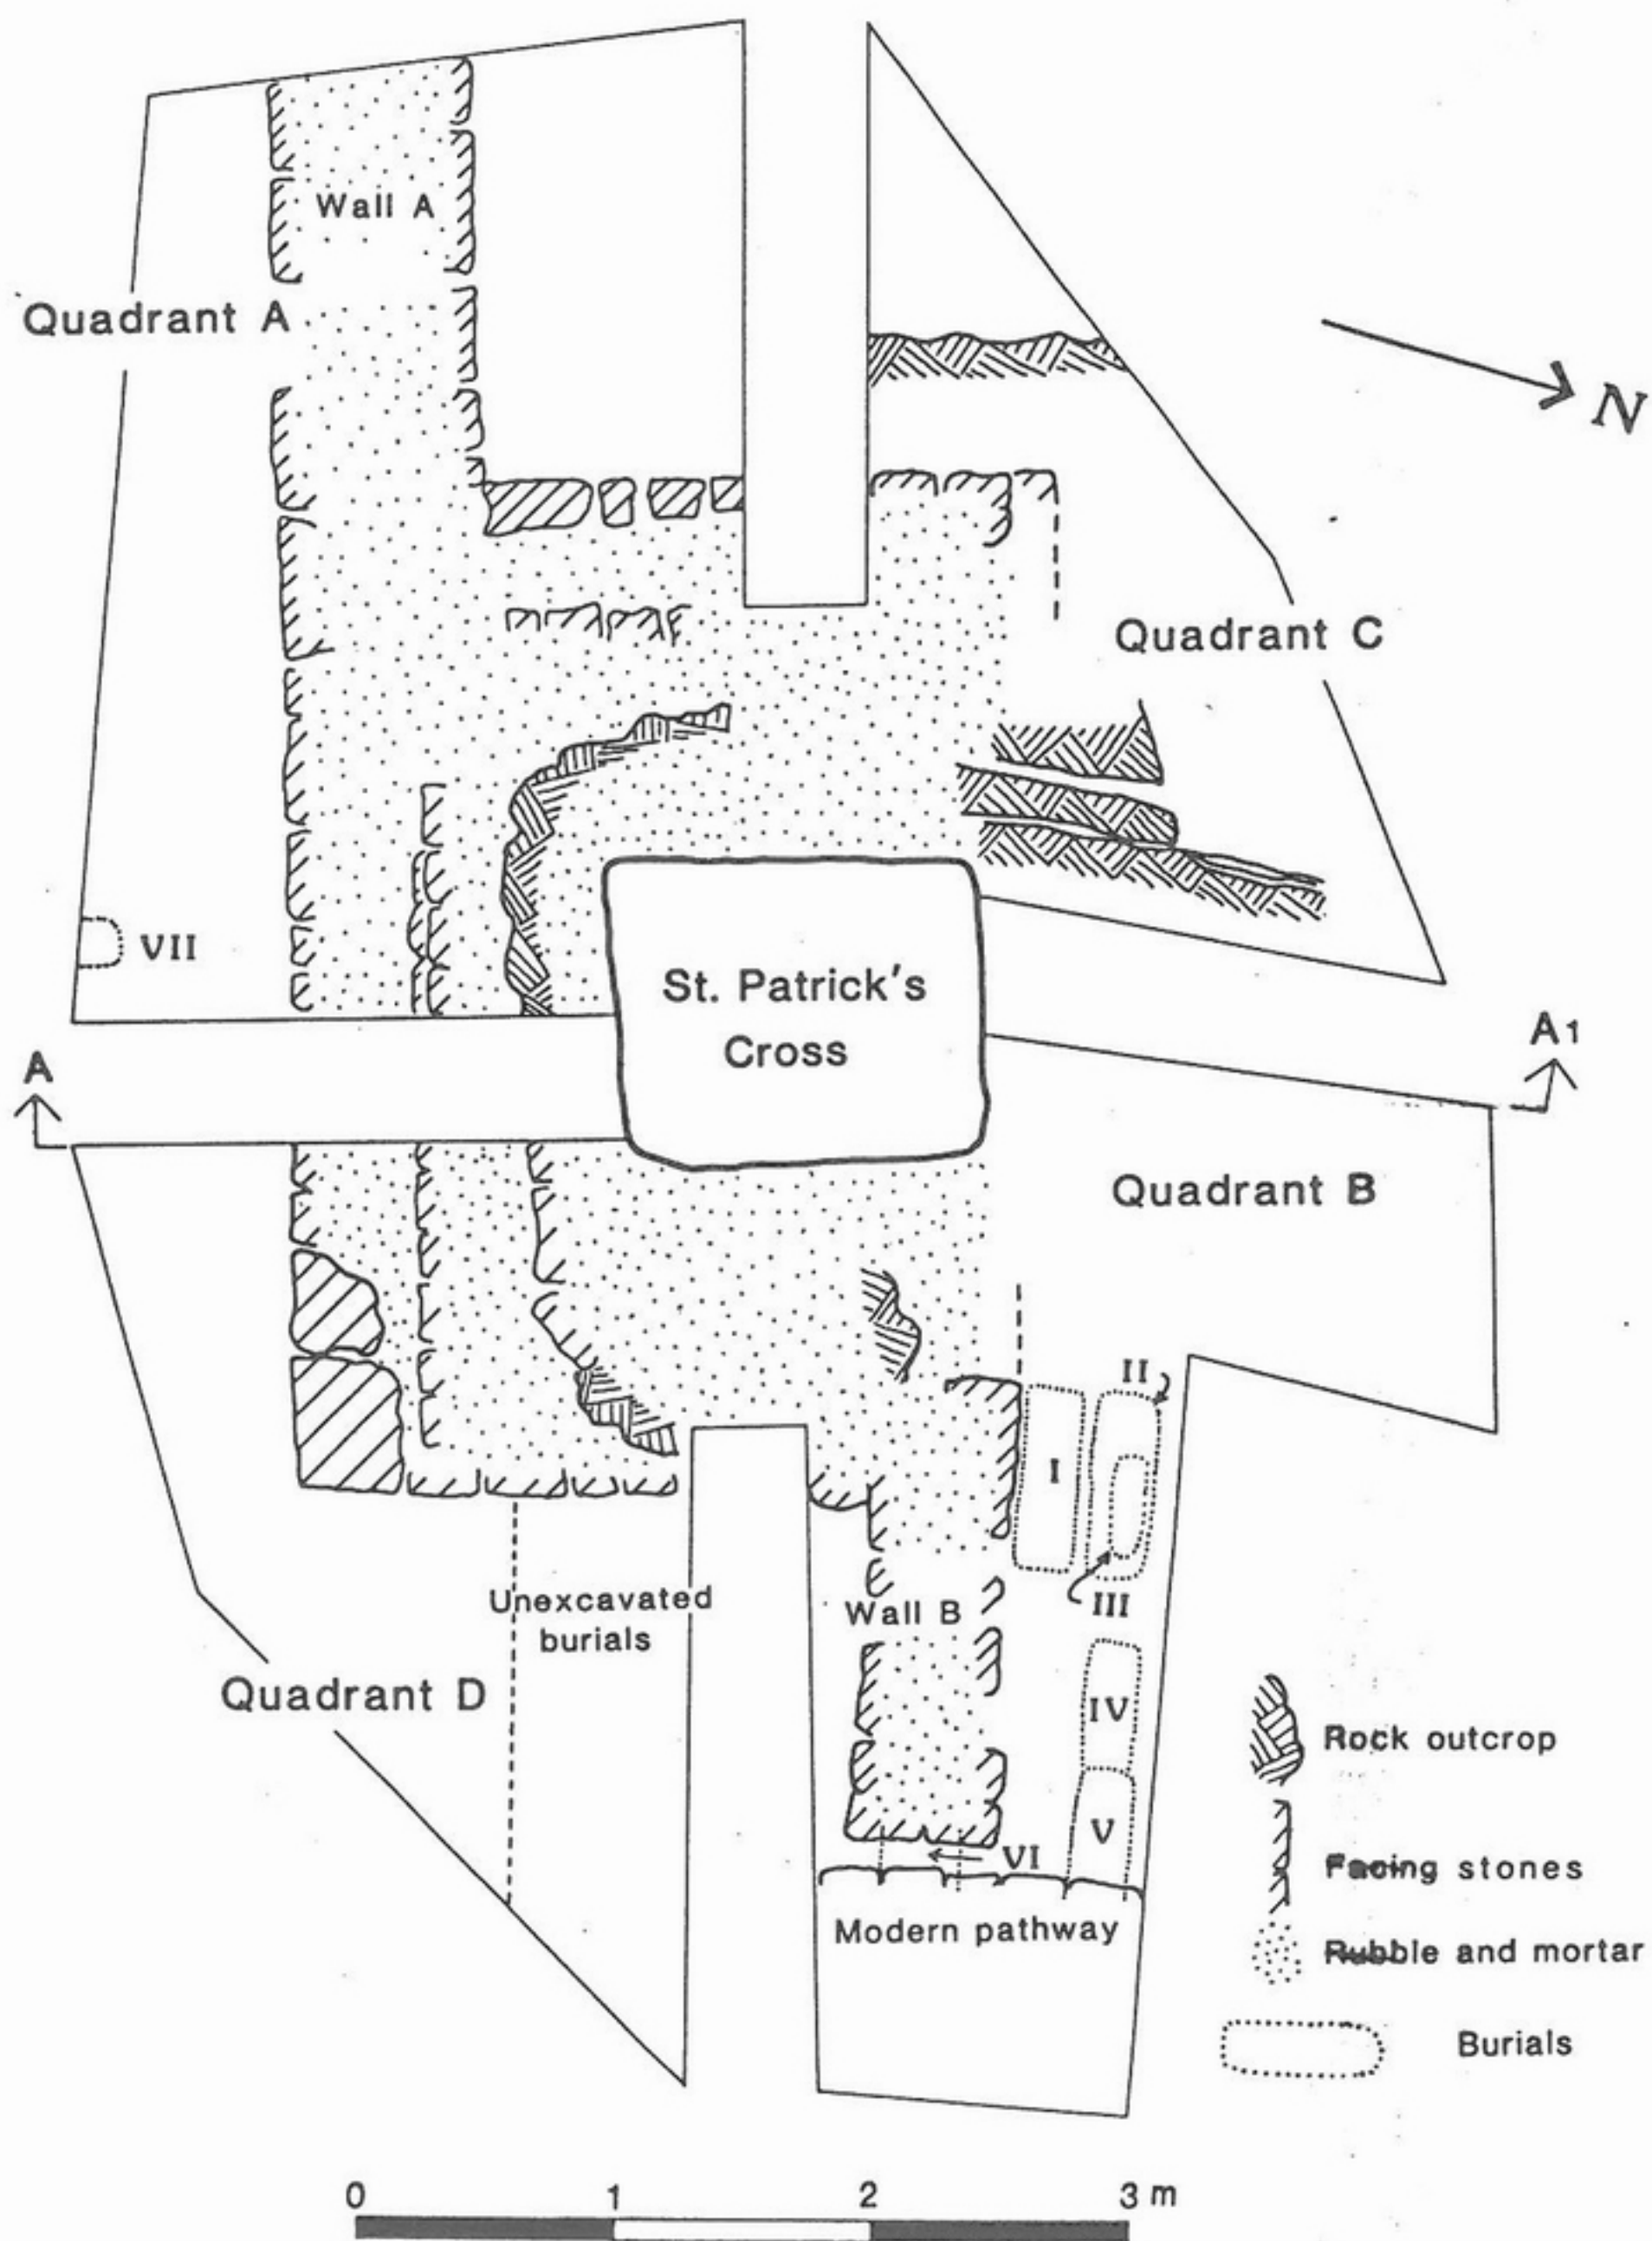
Fig. 4. Plan of excavation area showing stone-built plinth and other features.

Before excavation, the cross stood on a low grassy mound c.6m. in diameter and c.60cm. high. Two opposing quadrants of the mound were excavated before the cross was lifted (Fig. 4, Quadrants A and B) and the remainder was excavated after the cross had been removed and the replica put in its place (Fig. 5).

A stone-built plinth surrounding and bonded to the limestone outcrop was exposed (Figs. 4 and 5). This consisted of a core of mortar-bonded limestone rubble faced with limestone blocks, and on the southern and western sides, traces of two or possibly three steps could be seen. Few of the facing stones had survived but where present were large roughly dressed and closely-set blocks. The plinth survived to a maximum height of c.1.10m. on the southern downhill side, but the northern edge had at some stage been almost completely demolished (Fig. 1). Originally, the plinth on the northern or uphill side of the cross cannot have been more than one or two courses high since the maximum depth of the bedrock below the mound surface was 60cm.

The basal course of a wall (80cm. thick) extended westwards from the southwestern corner of the plinth (Fig. 4, Wall A). This wall is keyed into the plinth, and the masonry of both structures is similar, indicating contemporaneity. Two trial trenches were opened to the west of Quadrant A which showed that the wall extended for at least a further 7m. but its full length was not revealed.

from the northeastern corner of the plinth (Fig. 4, Wall B). This mortar-bonded wall is 60cm. wide and survives to a maximum height of 40cm. It is crudely constructed and not as substantial as Wall A, but nevertheless is probably contemporary with the plinth since no straight joint could be discerned at the junction of the two features.

Just to the east of Wall B a roughly paved surface was exposed running north-south (Figs. 4 and 5). The 'paving' stones were set into dark brown stony earth with charcoal flecks and, even though patches of mortar were found on top of the stones, the stones themselves were not mortar-bonded. This feature is most likely to be part of a path which led to the south doorway of the cathedral, and a relatively recent date is suggested by the thin covering (maximum 20cm.) of topsoil.

In Quadrant B, two badly disturbed adult skeletons were found within the mound, c.25cm. below its surface. They were lying immediately north of Wall B and in both cases neither the skull nor the leg bones had survived (Fig. 4, Burials I and II). Burial III (Fig. 4) was that of an infant placed in a crevice in the bedrock, underlying Burial II. Immediately to the east, lying close to the bedrock was an adult burial (IV) which was partly overlain by Burial V. The latter was in turn, partly overlain by the roughly paved pathway (Fig. 4). Burial VI underlay Wall B and the pathway and only its pelvic bone was exposed in the area between the two structures. The deposit in which Burials IV, V and VI were found consisted of a loose black stony soil with fragments of animal and human bone indicating disturbance.

Several undisturbed adult burials were partly exposed in Quadrant D (Fig. 4) but were not fully excavated. The burial deposit here was similar to that in Quadrant B and extended under the eastern edge of the plinth. No burials were recorded in Quadrant C.

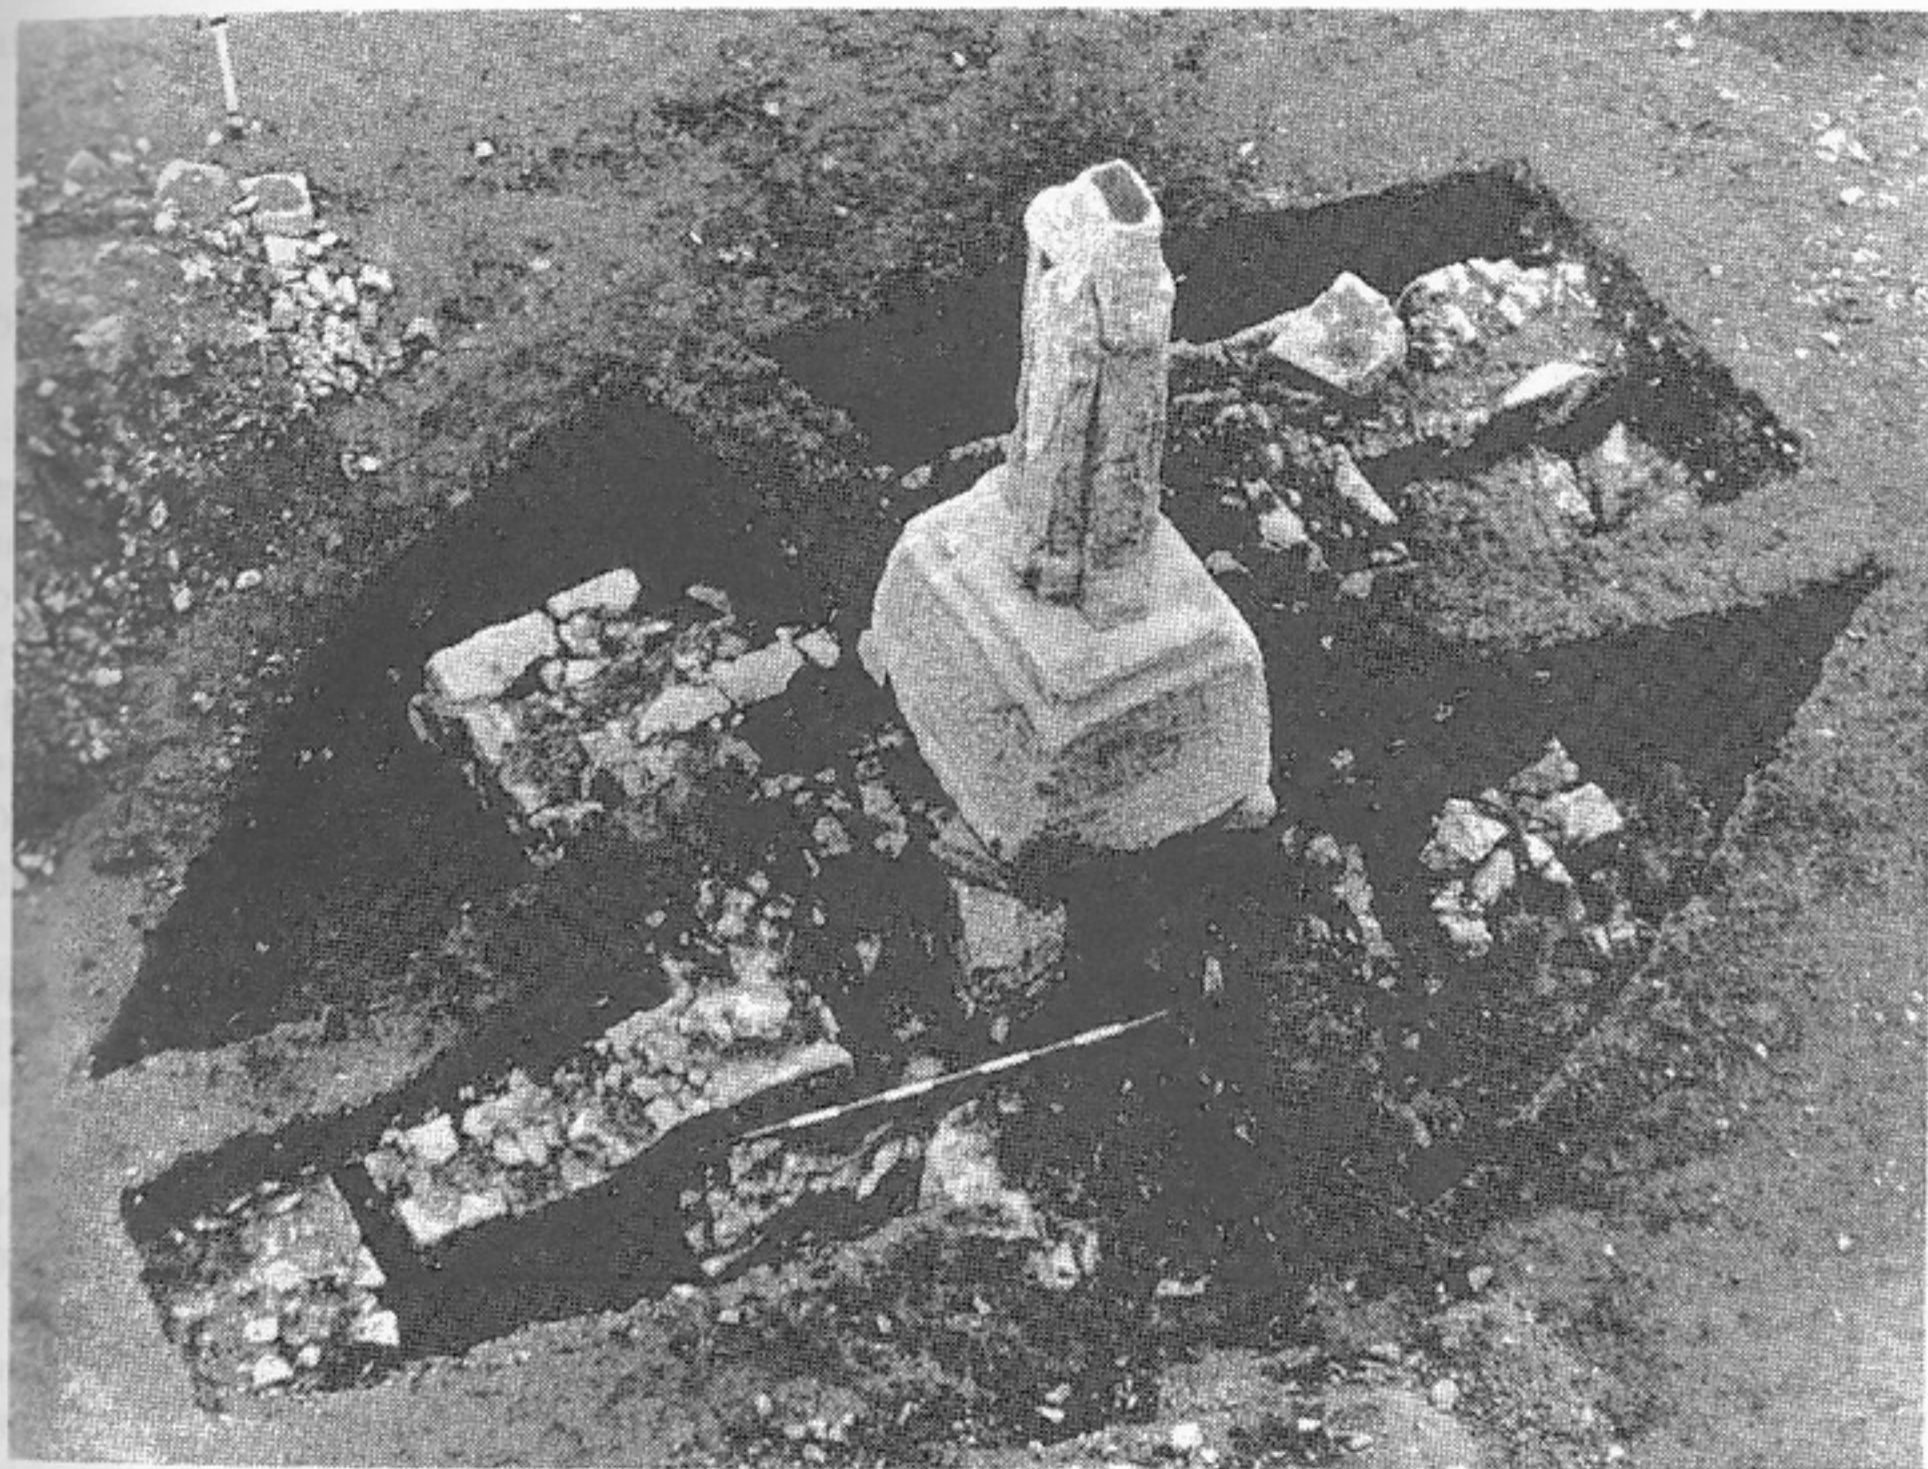
Fig. 5 The site after excavation, with the replica cross in position. Scale division = 20cm.
(Photo: Office of Public Works.)

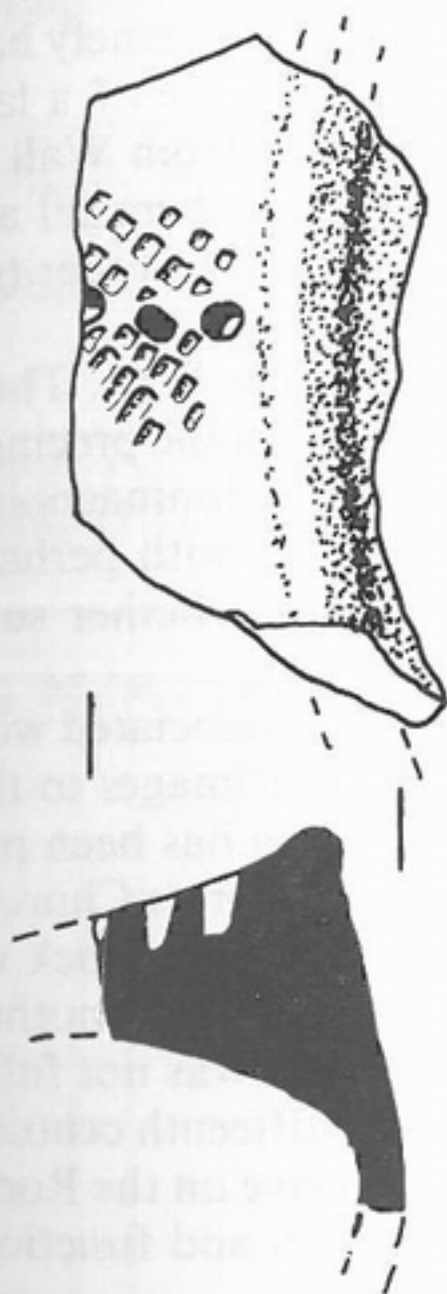
Fig. 7. Sherd of Ham Green Pottery (E268:1).

Two sherds of pottery were found during the excavation. E268:1 (Fig. 7) is the rim fastening of a handle from a Ham Green jug with a fairly typical form of decoration consisting of a row of three-stick end piercings with impressed lattice design on each side (Barton 1963, 110). Traces of light brownish-green glaze can be seen on the upper surface of the handle. The fabric, which is buff-coloured with a dark grey core, has very fine gravel or sand inclusions, and seems to correspond to Barton's Type B ware which he dates to mid/late thirteenth century (*ibid.*, 124). This sherd was found lying under the skull of Burial IV in Quadrant B.
