# Was Quin Castle Completed?

### **BRIAN HODKINSON**

Limerick Museum

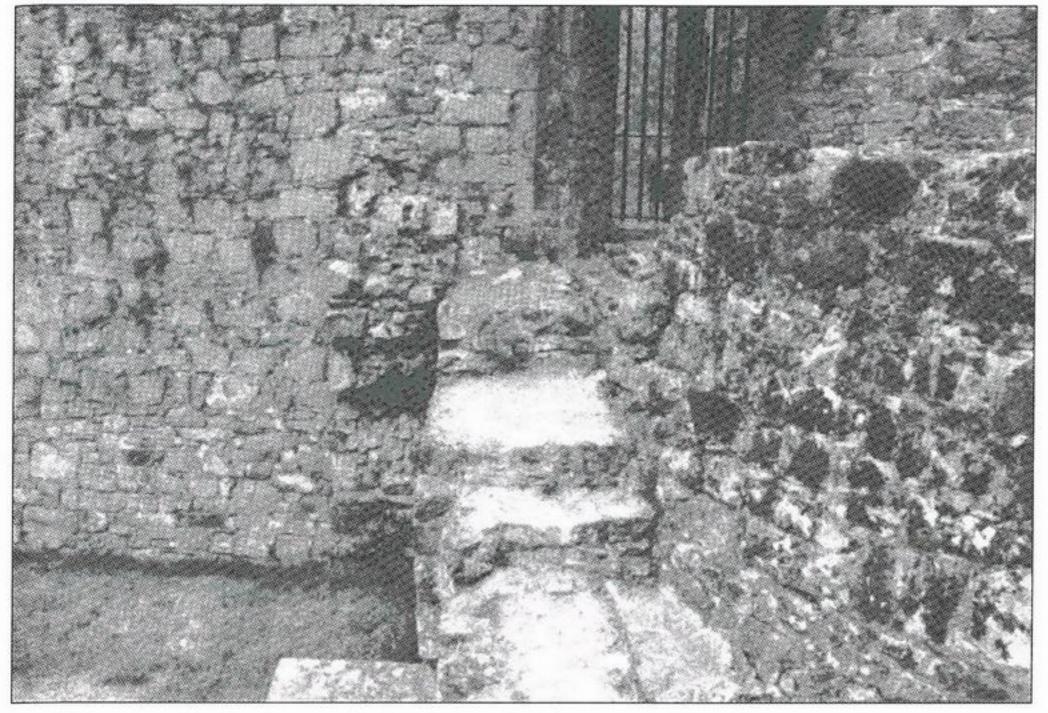
Fig. 2 The stub wall projecting out to the left of the wall of the square building: the tower wall is curving in from the right.

A close examination of the south wall shows the projecting stub of a wall, immediately to the west of the south-east tower, which is bonded into the lower part of the wall. This is distinctly separate from the wall of the later square building abutting the church (Figs 1 & 2). Its location suggests it is part of a garderobe arrangement similar to that seen on the north-east tower in the angle with the north wall. The stub wall rises to the same height as the tower and no further. There are two ways to interpret this: that the south wall was demolished down to top of stub wall level and was then rebuilt to the identical thickness or that the original castle wall had only been raised to more or less this height and the rest, including the windows of the church, is a later addition. The latter seems the more plausible. The castle wall had simply been built to a height where it was easier to carry on the thickness to church roof level than to demolish it. A further indication that the wall was built up was the need to extend the south wall slightly at either end in order to form corners within the area of the towers. This is best seen at the east end of the south wall, where the footing for the extension can be seen abutting the inner wall of the tower (Fig. 3). In fact the butt joint is carried vertically for just over a metre above the footing, in the angle of the right hand jamb of the window. This suggests the possibility that the outer eastern side of the window may have re-utilised one side of the first floor entrance to the tower. The cut stone around the outside of this window is found only at the springing stone of the right jamb but forms the full height of the left jamb.
