Earthworks at Raheen Castle, Co. Limerick

THOMAS FANNING AND KEVIN O'BRIEN

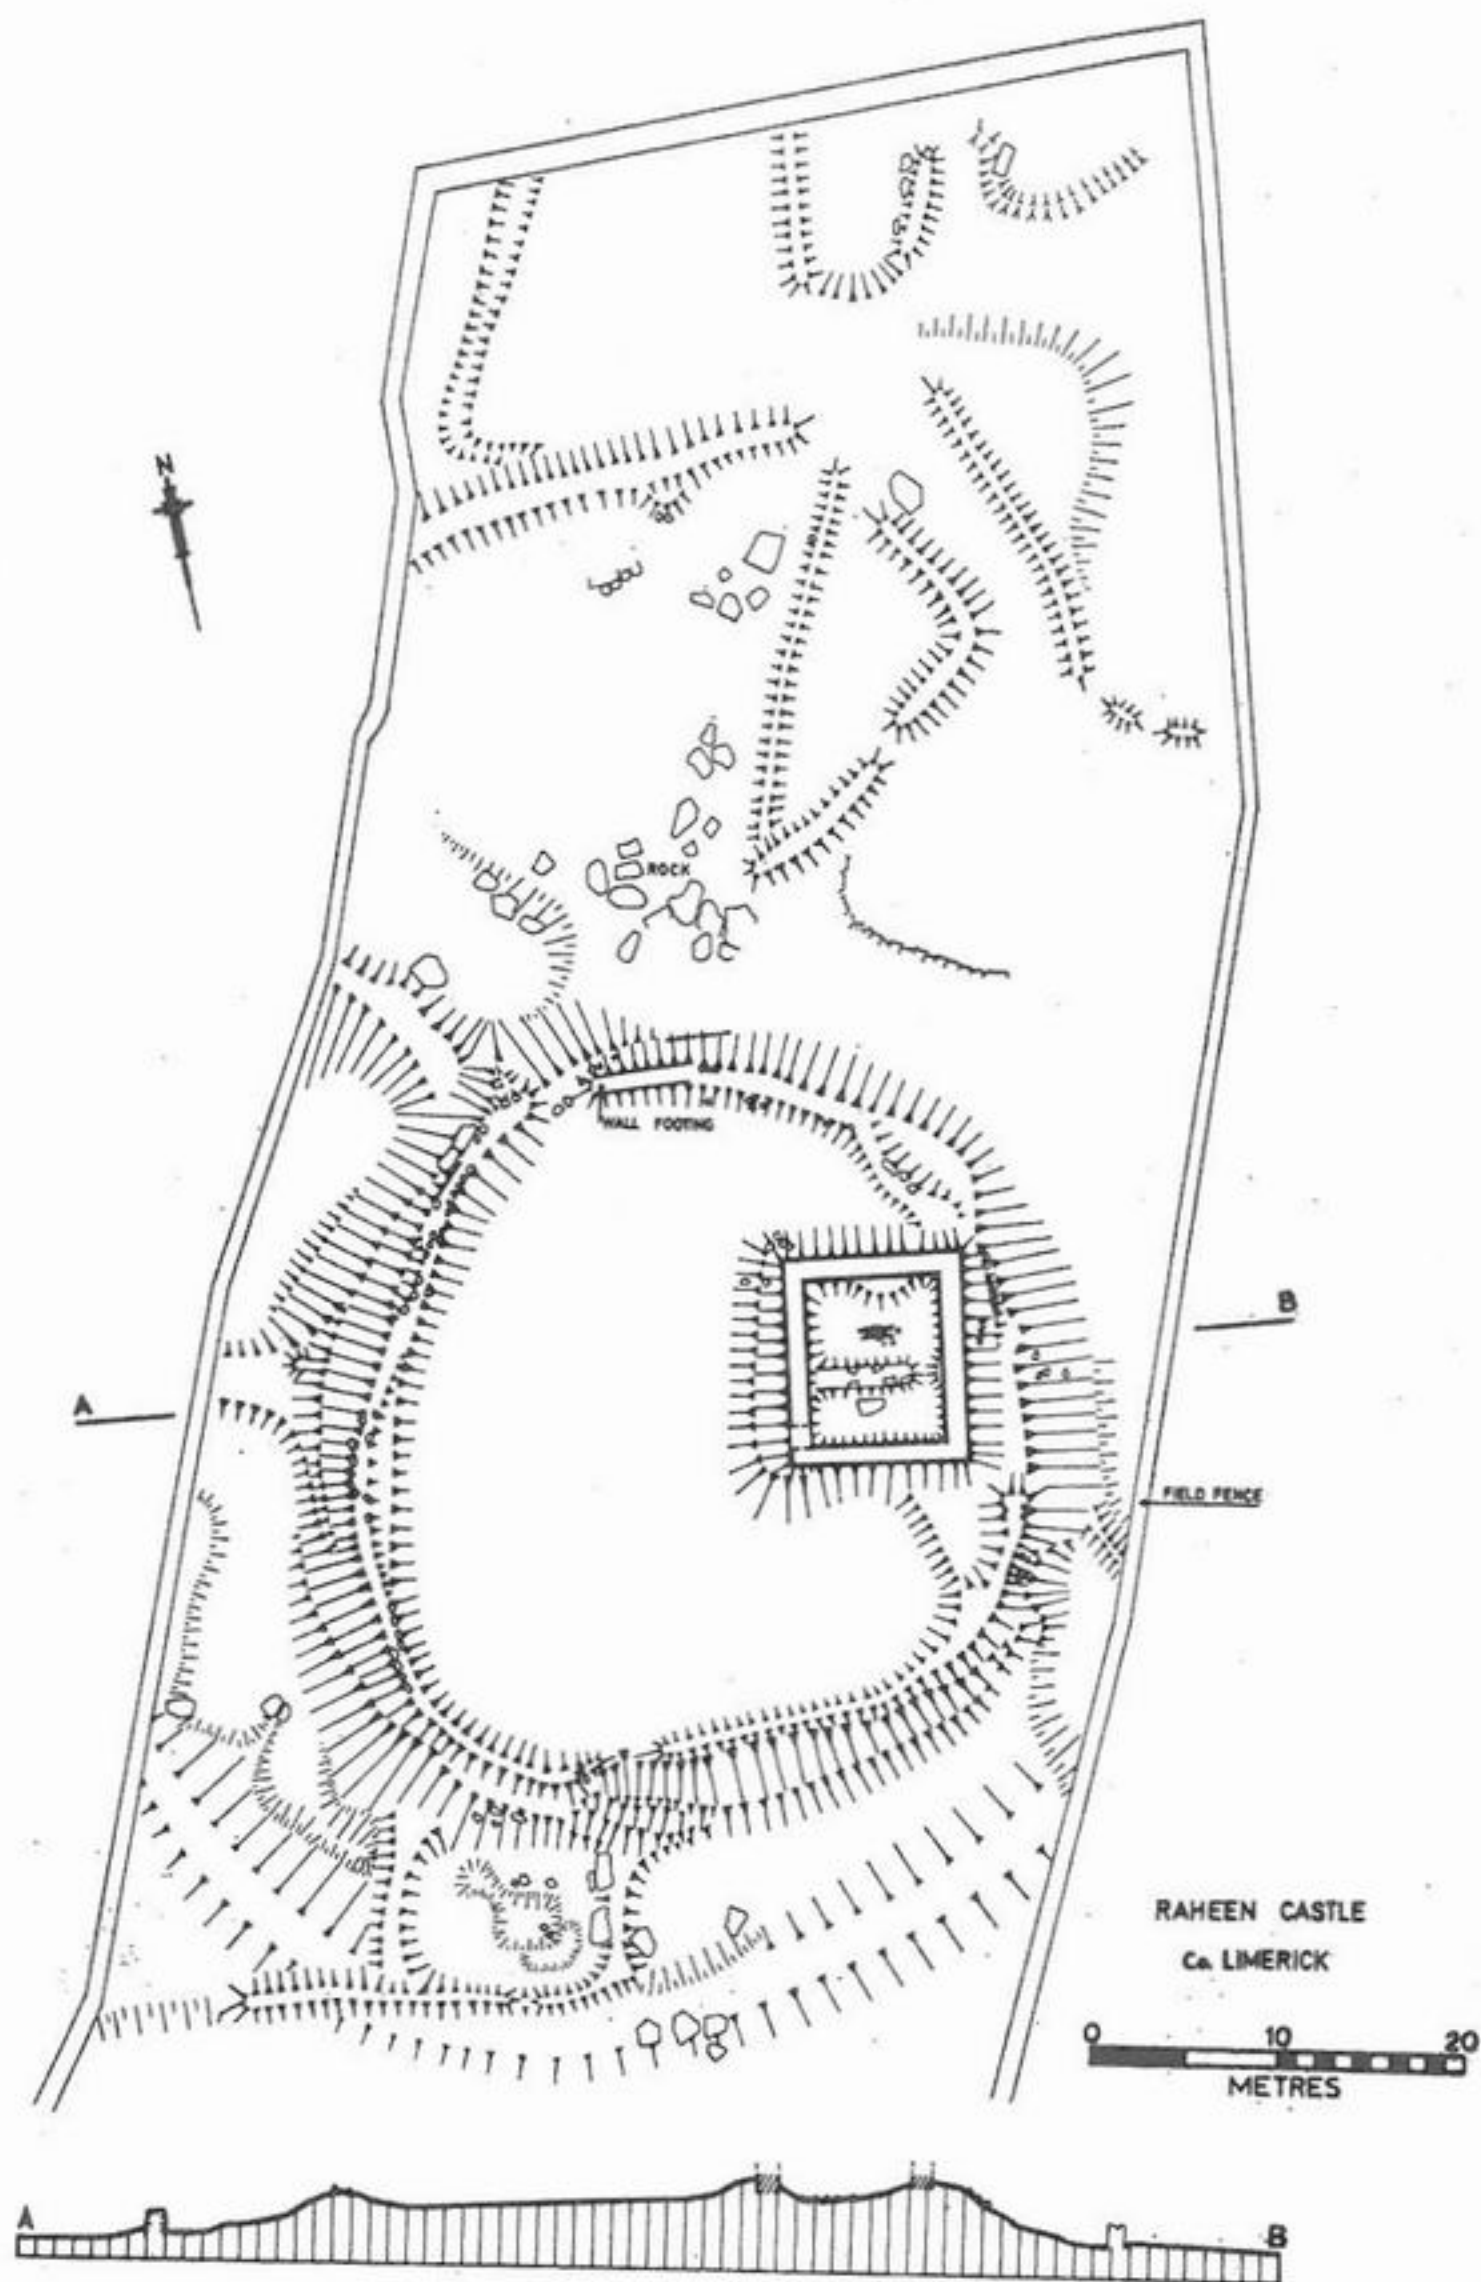
Fig. 1. Plan and section of castle and surrounding earthworks.

Only the foundations now remain of the fabric of the castle (Plate V, 2). These consist of a number of wall-footings of rectangular plan, measuring internally nine metres from north to south and seven metres from east to west (Fig. 1). The walls are, on average, one metre thick and four courses in height, with good facing-stones and a rubble core. There is no clear indication of an entrance, but one may have existed in the southern corner of the west wall. Internally a low grass-covered wall-footing extends eastwards from approximately the centre of the east wall and indicates some form of internal division, possibly of a secondary nature. A number of small mounds of collapsed stone, including some large wallstones, are the only other features visible within the walls.

As noted above, the castle is located within an earthwork roughly circular in plan and some thirty-five metres in maximum diameter. This earthwork, to which the term ringfort can in a general way be applied, is of the platform variety, and rises on the eastern side to a maximum height of about two metres above the surrounding field surface (see section, Fig. 1). The castle was built on a small, possibly artificially raised, area within the north-eastern quadrant, and was enclosed by a stone wall which was erected on the perimeter of the surrounding ringfort. Little survives of this wall but, in places, some of the facing-stones can be seen and a thickness of about one metre measured. The wall follows the circular plan of the earthen fort, but appears to have been built in straight sections with a possible entrance feature in the north-western corner. It probably represents the remains of the bawn wall which surrounded the castle, so providing a measure of defence and security for the inhabitants. Within such a wall the out-houses and associated structures could be accommodated, as also cattle or other livestock at night or in times of danger.

On the northern and western sides of the ringfort at Raheen, though not marked on the O.S. maps, there can still be seen amongst the limestone outcrop a number of low earthen banks, some of which survive to a height of about 70 cm.⁹ (indicated in Fig. 1). They are best preserved on the northern side of the enclosure but do not, to-day, extend beyond the modern field boundaries. Though obviously not all contemporary, some, at least, perhaps represent the boundaries of the small plots or orchards associated with a medieval rural settlement of Anglo-Norman character. In this regard, the location of the medieval church may be significant, situated as it is across the roadway from the castle, within a small graveyard. As Glasscock has pointed out in a recent survey,¹⁰ such a grouping of castle and church in close proximity
